## Pre-Purchase Visual Building & Pest Report

### 1 Sample Street, Sampleton

**Inspection Date/Time:** 2/08/2017.  
**Report Number:** 54321  
**Purchaser:** Mr Sample  
**Inspector:** A Reporter  
**Contact:** 0444 444 444  
**Special Requirements:** Please check for cracks in the living room walls

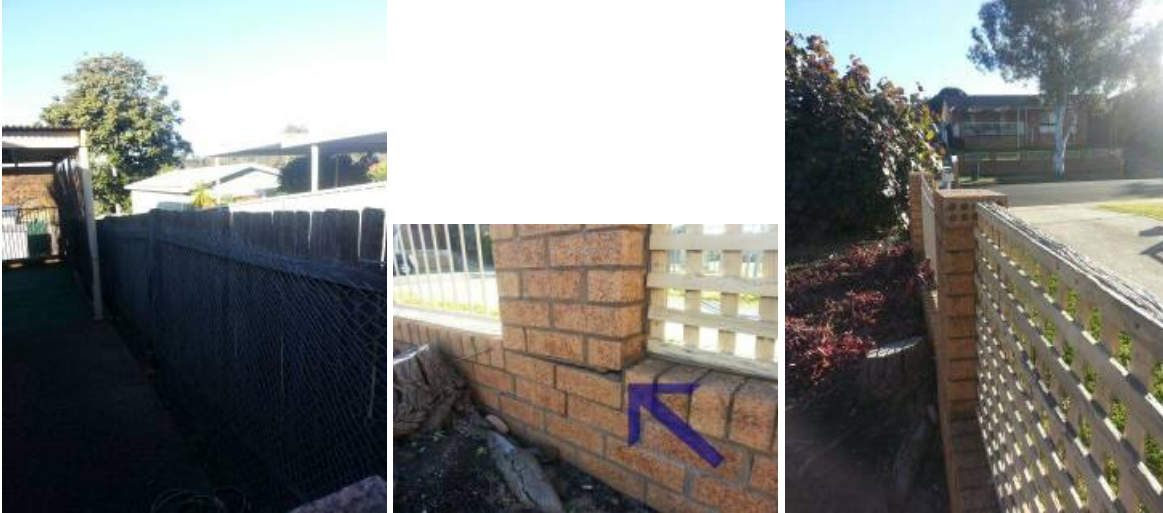
The fences are mainly constructed from timber. The fences are mainly constructed from brick. The fences are generally in fair condition but some repairs or maintenance are required. Brick fencing has signs of major cracking and will require repair and or replacement. The fences are leaning and repairs will be required.

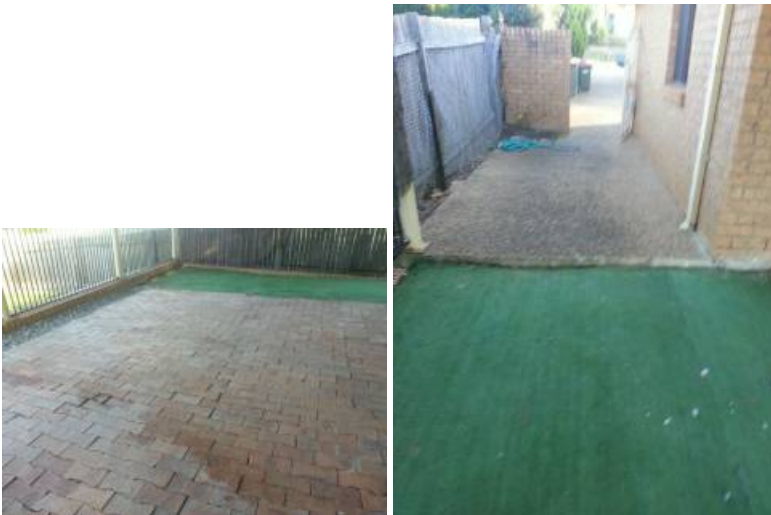
The paths/paved areas have some visible cracking and damaged areas may require repair and or replacement.  
The paved paths/paved areas have subsided in areas and will require repair and or relaying.

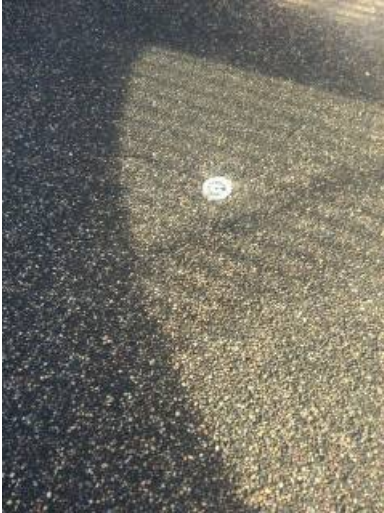
The surface water drainage at the front of the property appears to be inadequate. Drains should be installed to divert seepage and surface runoff water away from the building to prevent possible structural damage. The drains should be connected to a stormwater drainage system.

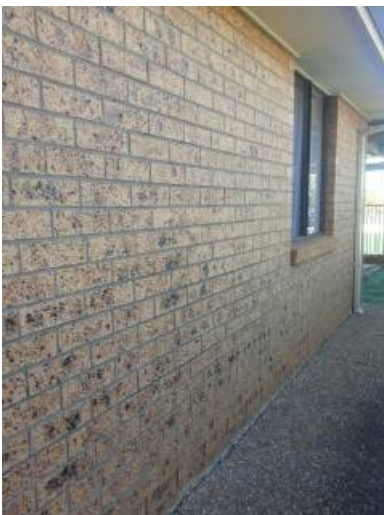
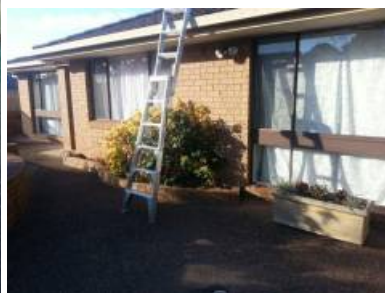
The condition of the walls is generally fair. The ground levels are close or covering the damp proof course material and should be lowered to prevent dampness problems. The height of a DPC, or flashing serving as a DPC is recommended be not less than 150 mm above the adjacent ground level, 75 mm above the finished surface level of adjacent paved, concrete or landscaped areas that slope away from the wall or 50 mm above finished paved, concrete or hard landscaped areas.

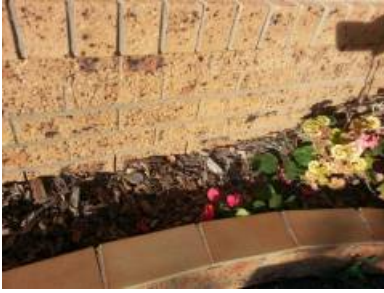
Weep holes are present to the base of walls. Weep holes to the base of the brick walls are blocked or partly blocked by gardens, soil or pathway heights and should be cleared to help prevent moisture and pest problems.

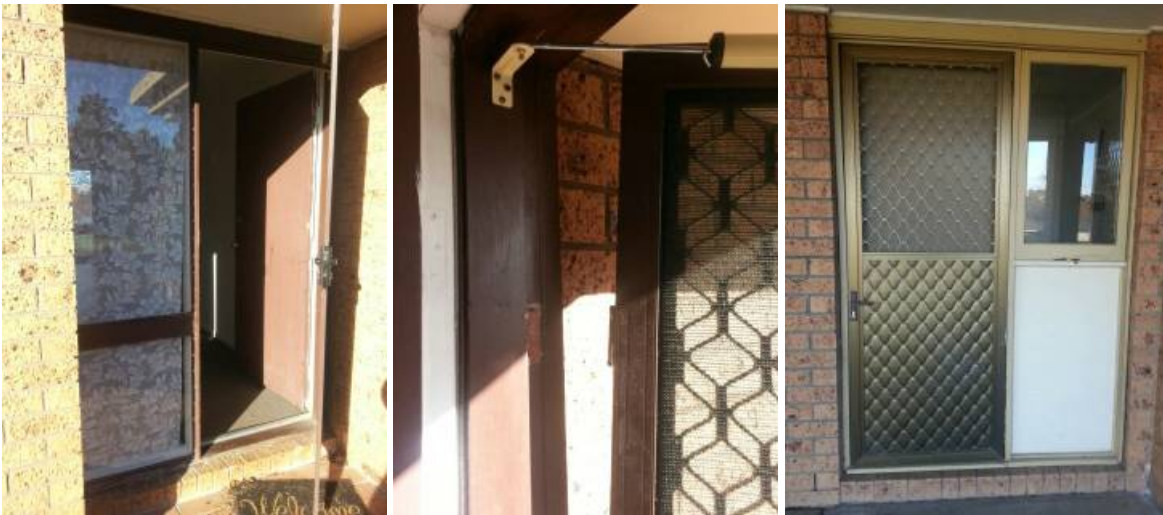
The condition of the exterior of the doors is generally fair. Paint is peeling off the door frames and maintenance is required. Minor maintenance and or repairs are required prior to next repainting. Rectification will be required.

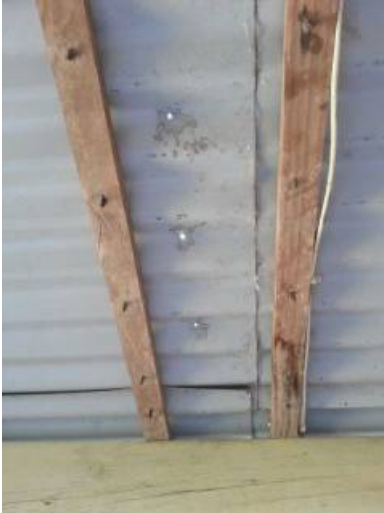
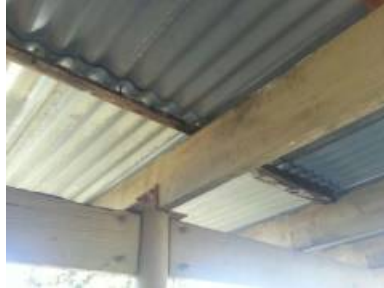
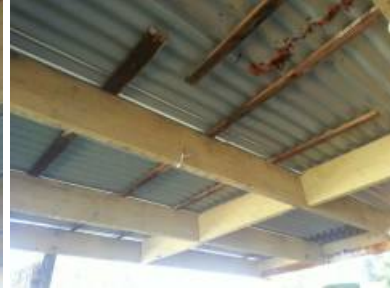
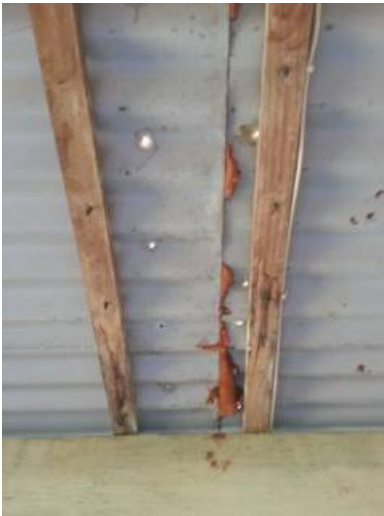
The overall condition of the roof coverings is poor. Metal roof sheets have been end lapped which is not considered good practice and can allow water to penetrate and cause corrosion. This should be rectified. The metal roofing is rusted and requires treatment to prevent further deterioration. The method used to fix the metal roof is considered incorrect or is inadequate and should be rectified. The pitch of this roof section appears to be inadequate. This may allow wind driven rain penetration or water ponding and remedial action is required.

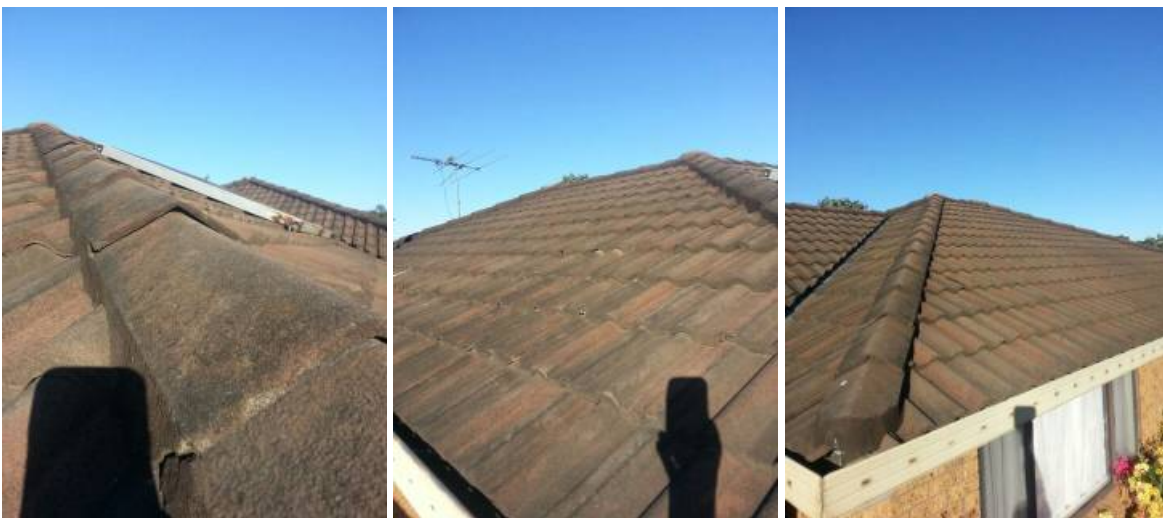
The overall condition of the roof coverings is fair. A significant number of cracked roof tiles were noted and should be replaced.

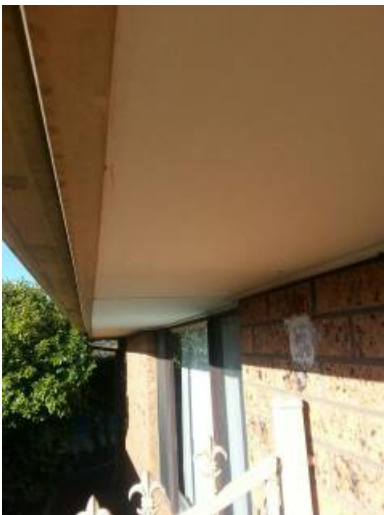
The eaves appear to be lined with asbestos fibre sheeting. Although we are not qualified in the detection of asbestos material, this item appears to contain asbestos. Asbestos material should not be disturbed or damaged and should only be removed or altered by a licensed asbestos removal contractor. Asbestos is hazardous to health and should be sealed to prevent exposure. Recommend an analysis by a qualified removal expert be conducted of these materials to confirm the amount and importance of the asbestos present, and the cost to seal or remove. The overall condition of the eaves lining is poor.

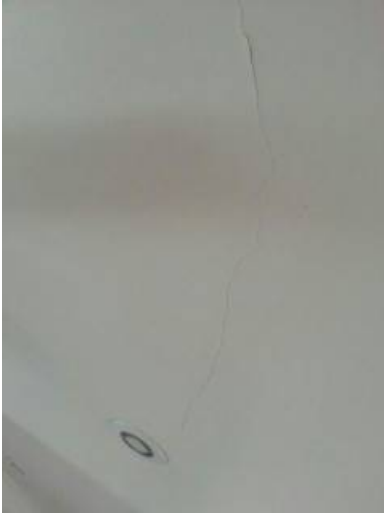
The condition of the ceiling area is generally acceptable, however, minor cracking is present to some of the cornices and these areas will require maintenance and or repair prior to next repainting. The condition of the ceilings is generally fair. Major settlement cracks were noted. Repairs will be necessary and you should engage a Structural Engineer to investigate the cause of this cracking. Moderate undulations were noted to the ceiling lining. Periodic maintenance will be required. Painting is in poor condition and recommend repainting. Rectification will be required.

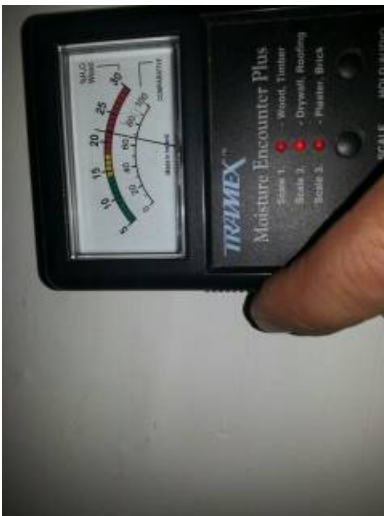
The condition of the walls is generally fair. High moisture is also an indication of possible termite activity, a invasive inspection would need to be carried out to determine the cause of detected moisture. Minor maintenance and or repairs required prior to next repainting. Settlement cracks are evident to wall areas. Maintenance and repairs are required prior to next repainting. Lateral dampness was detected in the wall backing onto the bathroom. This could be the result of a plumbing leak or leaking bathroom fixture and should be further investigated.

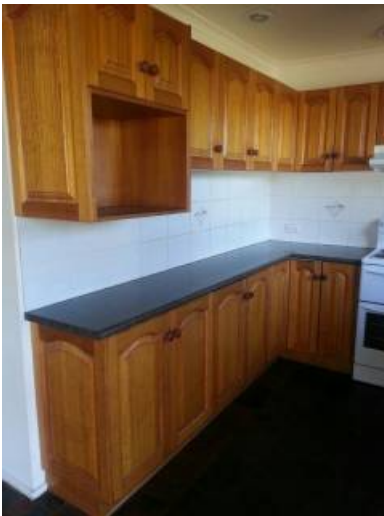
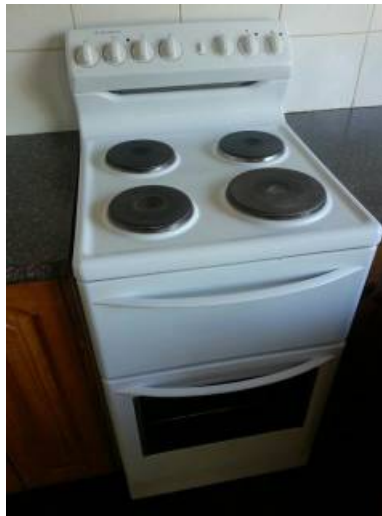
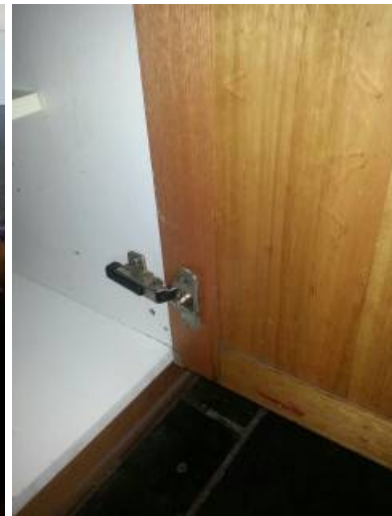
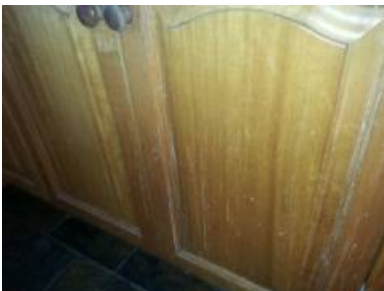
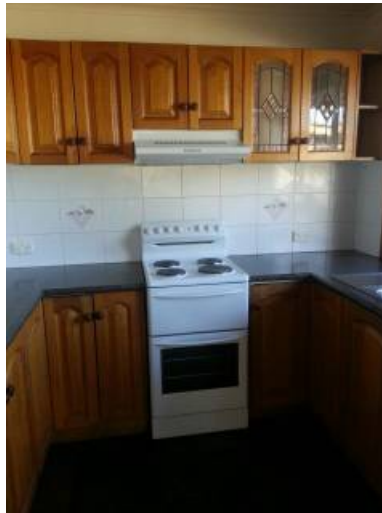
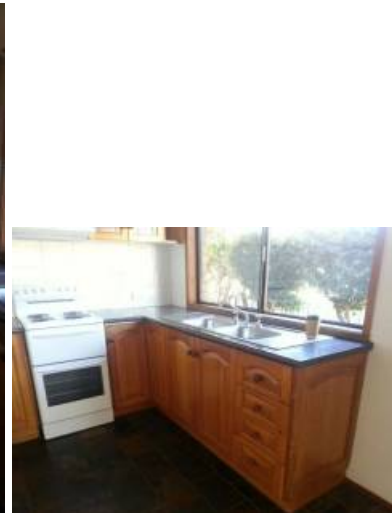
The condition of the fixtures is generally fair. A range hood is present however, it does not appear to be ducted correctly. Recommend the unit be ducted to the external air. Wear and tear is noted to cabinets and some maintenance or repairs will be required. Maintenance and adjustments should be considered to doors/drawers to provide smooth operation. The oven/cooktop is loose and requires re fixing. Potential to cause serious injury or death.

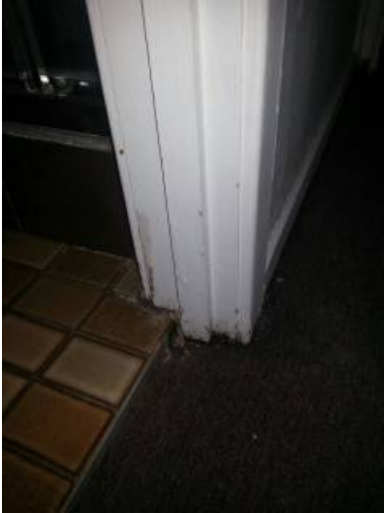
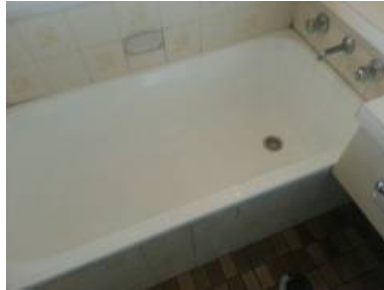
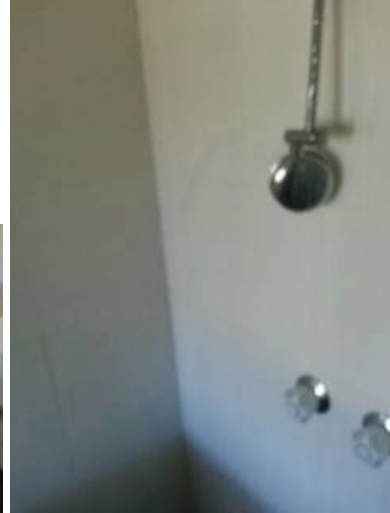
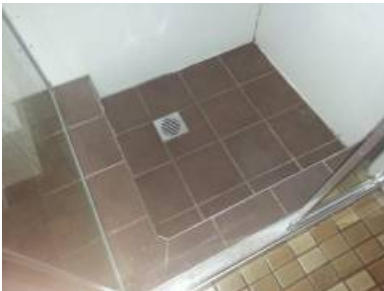
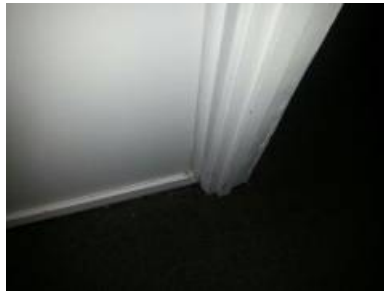
The shower recess was tested and found to be leaking. Lateral dampness was detected in the wall backing onto the shower. This could be the result of a deteriorating /damaged waterproofing membrane, a plumbing leak or leaking bathroom fixture and should be further investigated. Silicone sealant has been applied to the interface of the floor and walls in an apparent attempt to prevent water penetration to surrounding areas. This method of repair can only be considered to be temporary. Further waterproofing may be necessary. The bath appears to be in fair condition. The area will need to be kept well sealed to prevent water penetration to surrounding areas.

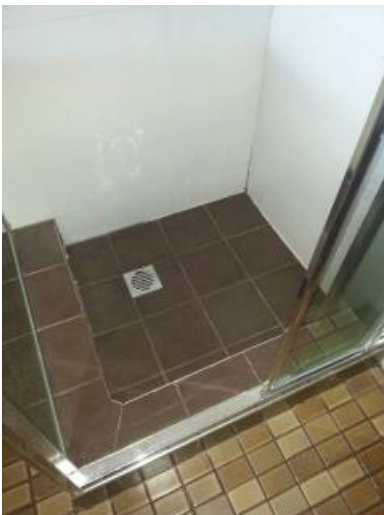
Tiles appear to have been laid over existing tiles. Suitable waterproofing may not have been applied or existing may not be suitable. Further investigation is recommended, It was noted that tiles within shower recess have appeared to have been replaced. This may be due to past waterproofing issue. Further investigation required.

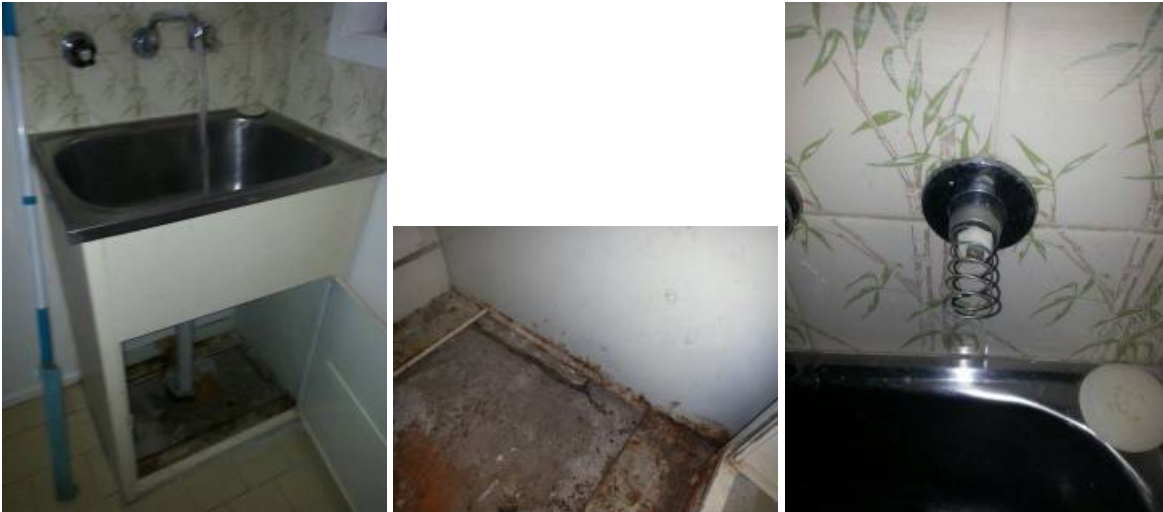
Taps require repair and maintenance to operate correctly. The metal tub cabinet is rusting and will require treatment or replacement.

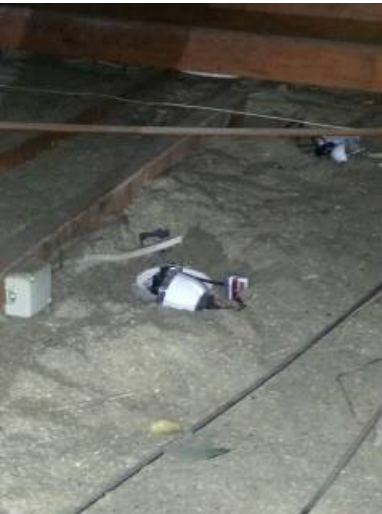
Insulation has been provided to the roof void. Insulation is covering lights and electrical fittings in the roof void. This may cause overheating and possibly a fire. Consult a licensed electrician to check on these installations and take necessary action to rectify. Loose fill insulation was sighted within roof void. Certain types of loose fill insulation contains asbestos. We suggest that you have loose fill insulation tested by a specialist to determine if it contains asbestos or not.

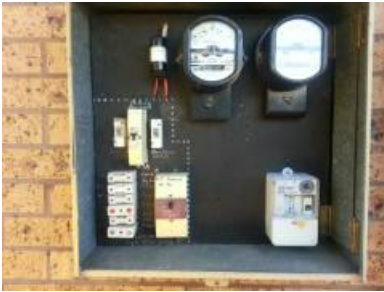
The cold water was operational but the adequacy was not tested and is not commented on. Smoke detectors are fitted, however, the positioning, operation or adequacy was not tested and is not commented on. Ceramic electrical fuses were identified to the electrical circuit board and these type of fuses are an outdated electrical safety device. To improve electrical safety we recommend this form of circuit protection equipment be upgraded by an electrician. Power was not functional to the premises at time of inspection. This may or may not indicate a problem with the electrical system. It is recommended that a Licensed Electrician be engaged to inspect and comment on the condition of the wiring service. This should be carried out prior to the final purchase of the property.

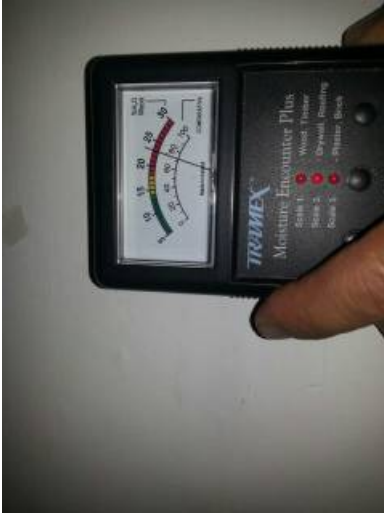
Hallway.

High moisture levels were detected to some internal walls as noted below. The moisture was considered higher than acceptable for the property inspected. This can be an indicator of a free moisture source (water leak) or possible timber pest activity. In all cases where a high moisture level is encountered, we strongly recommend further investigations be carried out to determine the cause of this situation. Moisture was tested in the range of: 80%
