Visual Completion Report

1 Sample Street, Sampleton

Inspection Date/Time:	30/01/2017
Report Number:	54321
Purchaser:	Mr Sample
Inspector:	A Reporter
Contact:	0444 444 444
Special Requirements:	Please meet client on site

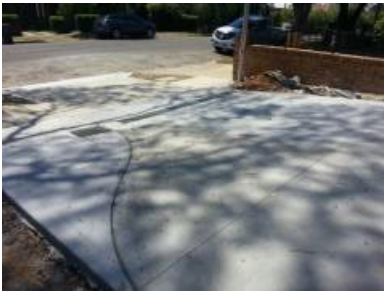
The concrete driveway stands in fair condition. The driveway area has not been sealed to prevent deterioration.

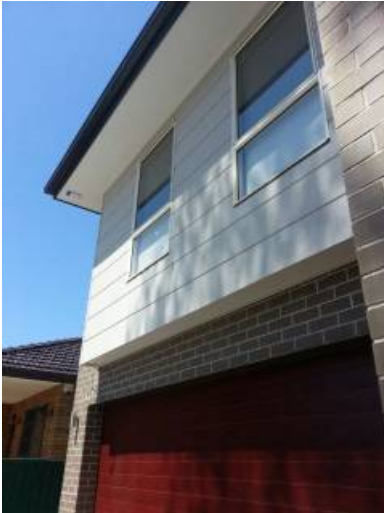
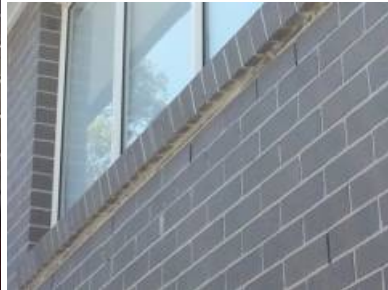
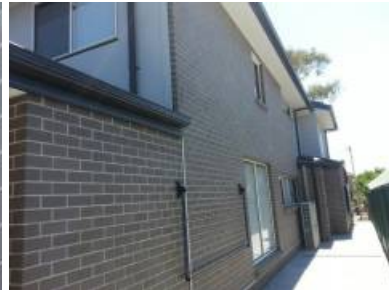
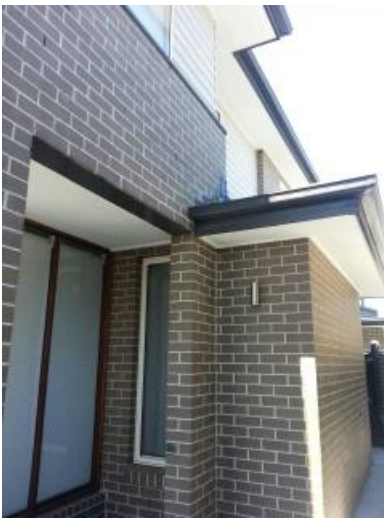
The condition of the walls is generally fair. Some areas require cleaning.

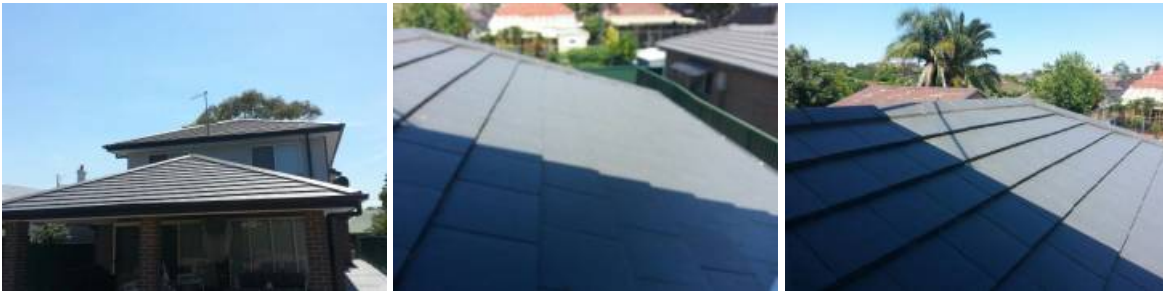
The overall condition of the roof coverings is fair. The overall condition of the roof coverings could not be determined due to limited access.

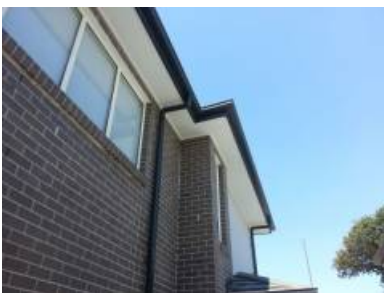
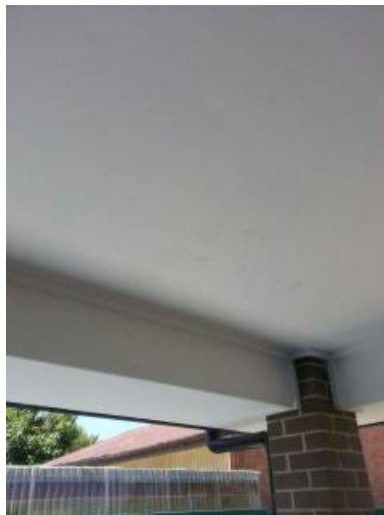
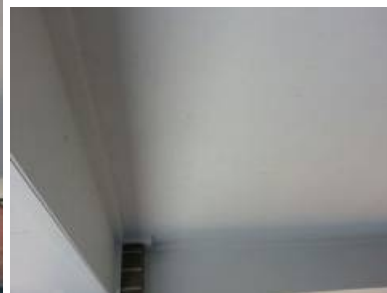
The eaves appear to be lined with fibre cement sheeting. The overall condition of the eaves lining is fair. Painting is not complete, appears transparent and requires rectification to provide a suitable finish.

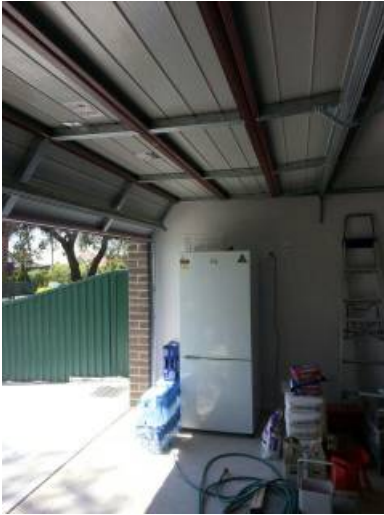
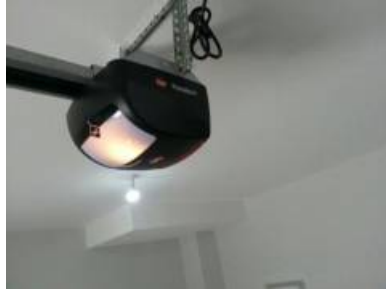
The main garage door is a tilt style door and is in fair condition.

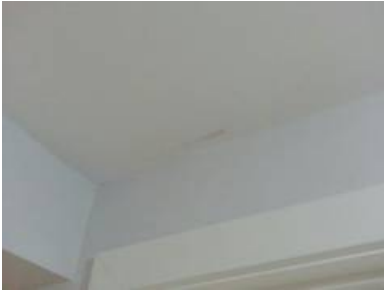
The condition of the ceilings is generally fair. Paint needs touching up in spots.

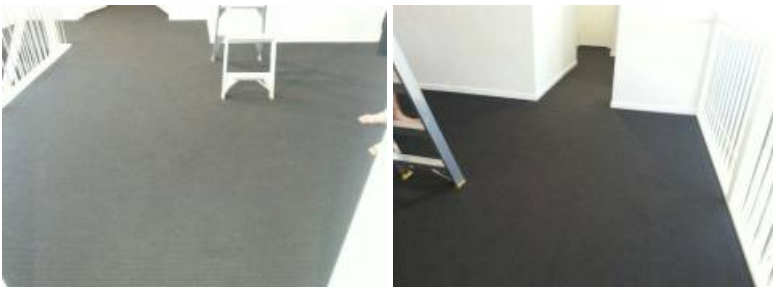
The condition of the floors is generally fair. Floors are concealed by floor coverings. Defects may be present and not detected. Stored goods restricted inspection of the area. Defects may be present and not detected. Floors are uneven and recommend that the re-leveling of the uneven floor area/s be considered.

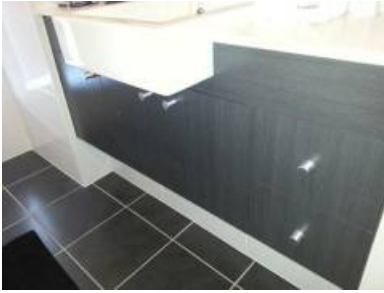
The condition of the vanity unit is generally fair. Wear and tear is noted to vanity cabinet.

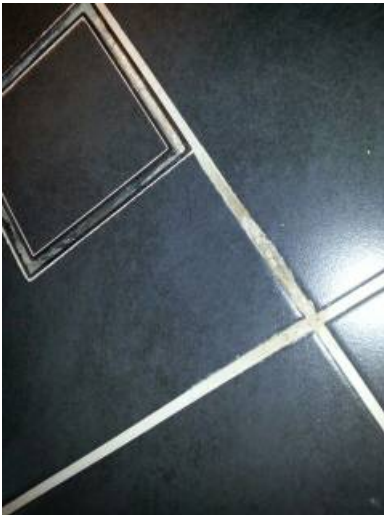
The condition of the tiles is generally fair. Grout discrepancies.
