Pre-Purchase Visual Building Report

1 Sample Street, Sampleton

Inspection Date/Time: 28/07/2017.
Report Number: 54321
Purchaser: Mr Sample
Inspector: A Reporter
Contact: 0444 444 444
Special Requirements: There are NO Special Requirements / Conditions requested by the Client/Clients Representative regarding this Inspection and Report:

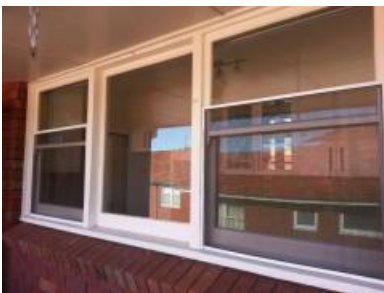
The condition of the exterior of the windows is generally fair.

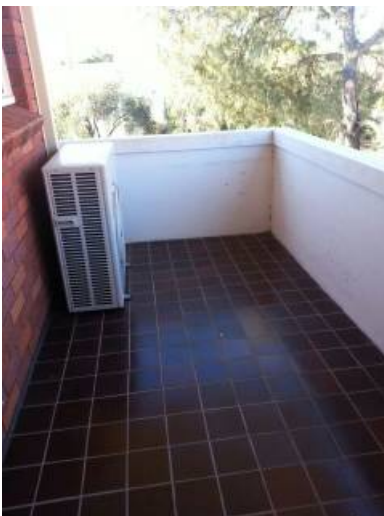
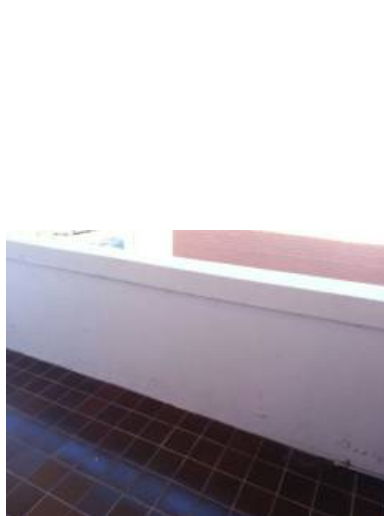
Front elevation.

Constructed from concrete or masonry. The general condition of this structure is fair.

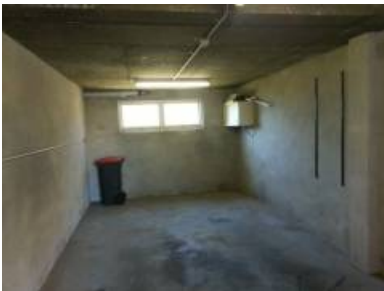
The structure is generally in fair condition.

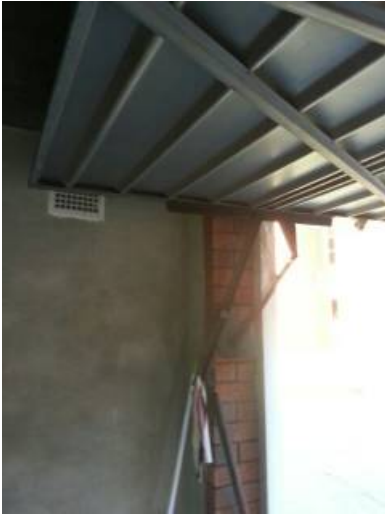
The main garage door is a tilt style door and is in fair condition.

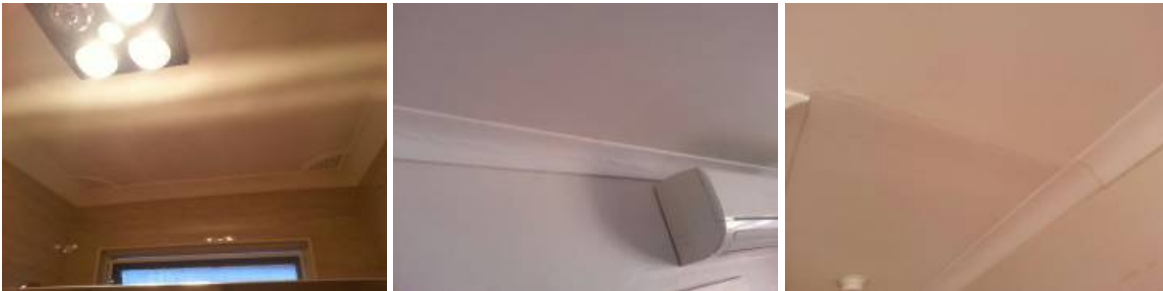
Bathroom.

The condition of the ceiling area is generally acceptable, however, minor cracking is present to some of the cornices and these areas will require maintenance and or repair prior to next repainting. The condition of the ceilings is generally fair. Minor settlement cracks were noted and these are typical of this type of material. Periodic maintenance may be required. Peeling paint was noted to ceilings. Mould was noted to the ceiling lining. The cause of this mould should be further investigated by an expert in mould detection and analysis. Recommend a specialist be commissioned to report on all mould present to this property.

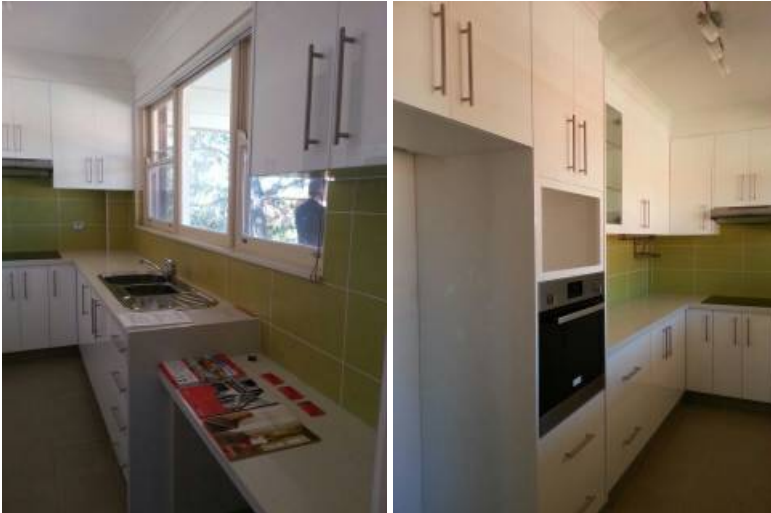
The condition of the fixtures is generally fair. Wear and tear is noted to cabinets and some maintenance or repairs will be required.

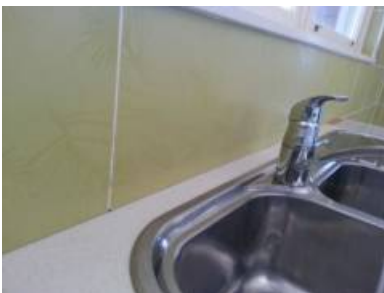
The condition of the tiles is generally fair. Movement and or settlement cracking to the junctions around fixtures, wall to wall and wall to floor junctions, should be filled with a flexible sealant to provide an acceptable finish and prevent water penetration.

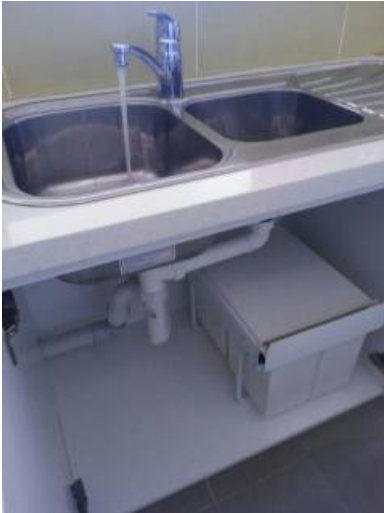
Sink and taps appear in serviceable condition. Drain appears serviceable.

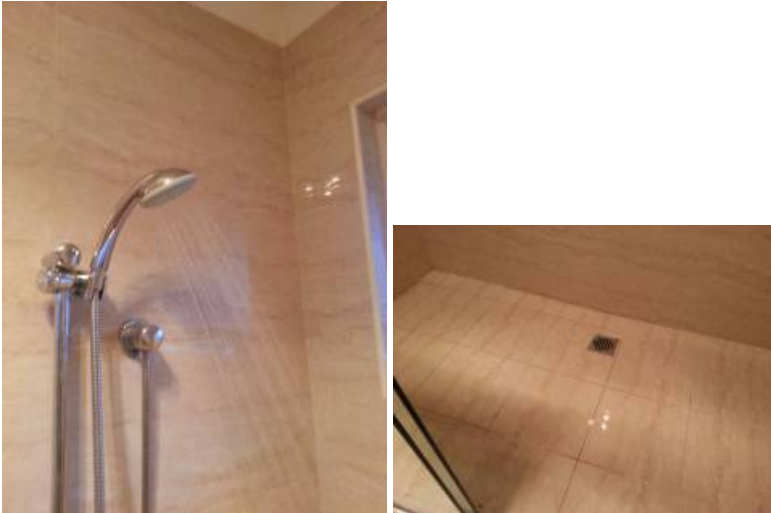
The shower recess was tested and there was no visible water penetration to surrounding areas. **IMPORTANT NOTE:** This test may not reveal water leaks until the shower is put into constant use and surrounding areas monitored over a period of time.

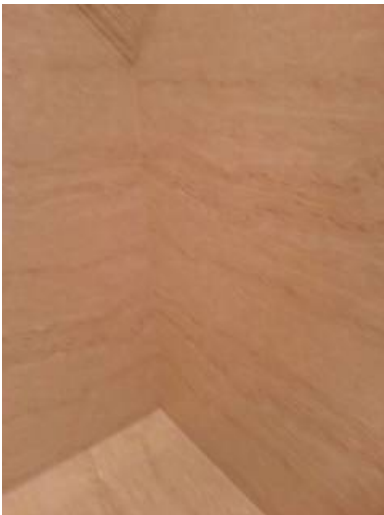
The condition of the tiles is generally fair. Movement and or settlement cracking to the junctions around fixtures, wall to wall and wall to floor junctions, should be filled with a flexible sealant to provide an acceptable finish and prevent water penetration.

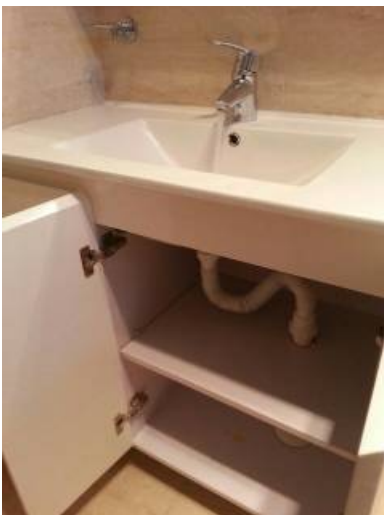
The basin & taps appear serviceable. Drain appears serviceable.

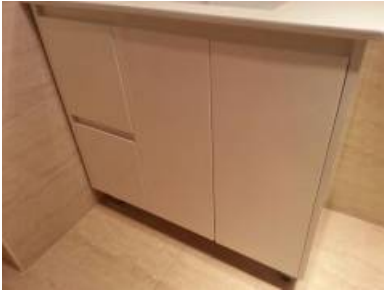
The condition of the vanity unit is generally fair.

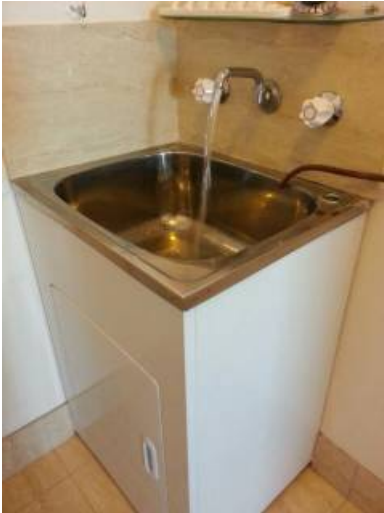
The tub and taps appear serviceable. Drain appears serviceable.

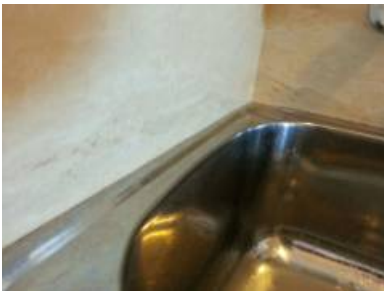
The condition of the tiles is generally fair. Movement and or settlement cracking to the junctions around fixtures, wall to wall and wall to floor junctions, should be filled with a flexible sealant to provide an acceptable finish and prevent water penetration.

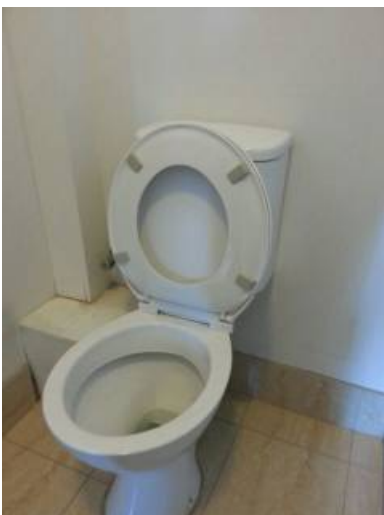
The toilet appears to be in working order.

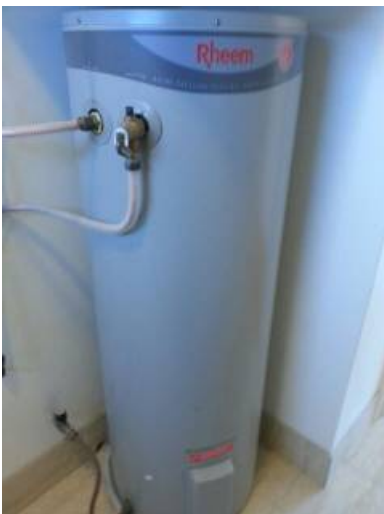
Mains electric hot water system: Located in the laundry:

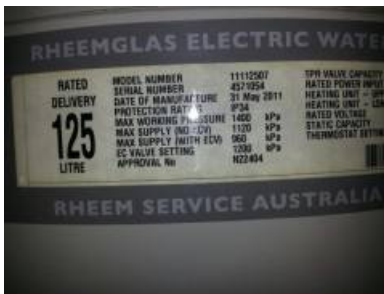
The unit was manufactured in 2011.

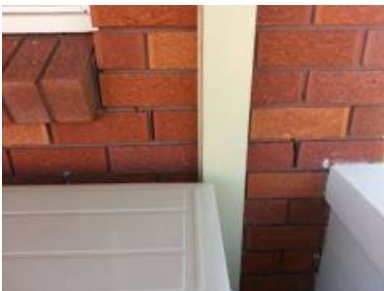
Crack Type: Stepped cracking Located: Balcony Width: 5mm Length: 500mm.

Due to the unpredictable nature of cracking in building elements it is not possible for the inspector to determine past or future occurrences that have or will impact cracking in this building. Because of these unknowns and the possibility of concealed defects related to cracking in building elements we recommend an engineer be consulted prior to acceptance or purchase this building.

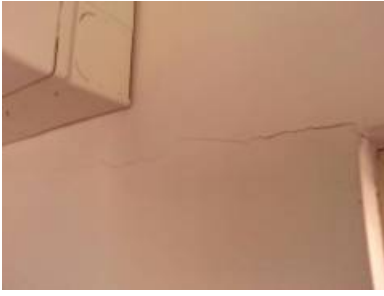
Crack Type: Random hairline cracking Located: Various.
