# PropertySafe Home

12 Smith Street, The  
Entrance NSW 2261

**Inspection Type:** PropertySafe Standard + FireSafe Report

**Reference:** I23848

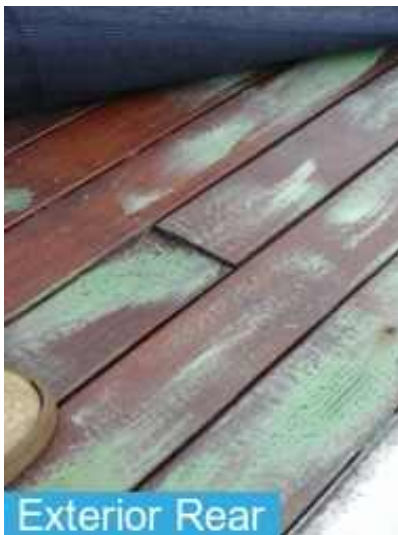
**Damaged flooring due to the following condition: rot/decay. Hazard Identified in Exterior Rear.**

Current Risk	Actions	Potential Solutions	Resultant Risk
Low	Eliminate	Replace, reinforce and repair as required or cover the damaged area with secure panels.	Nil
Low	Alert	Safety message to the residents - "As with many properties the presence of lower risk building related issues are often present. As a result, we respectfully ask that you, your family and your guests take suitable care when near this issue, and in particular be vigilant of young children, unsteady adults and the elderly. Your cooperation will increase the safety for all."	Very Low
Low	Isolate	If practicable, prevent physical access to the area by locking or barricading.	Very Low

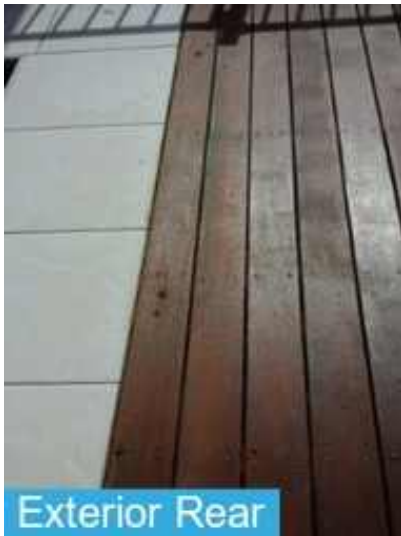
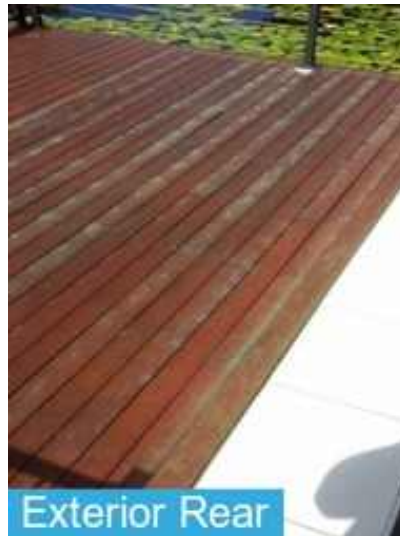
Separating balcony/deck attachment due to the following condition: detachment. Hazard Identified in Exterior Rear.

**Comments** Any load on this deck and it will fail causing harm.

Current Risk	Actions	Potential Solutions	Resultant Risk
Moderate	Eliminate	Replace, reinforce and repair as required.	Nil
Moderate	Alert	Safety message to the residents - "As with many properties the presence of lower risk building related issues are often present. As a result, we respectfully ask that you, your family and your guests take suitable care when near this issue, and in particular be vigilant of young children, unsteady adults and the elderly. Your cooperation will increase the safety for all."	Low
Moderate	Isolate	If practicable, prevent physical access to the area by locking or barricading.	Very Low

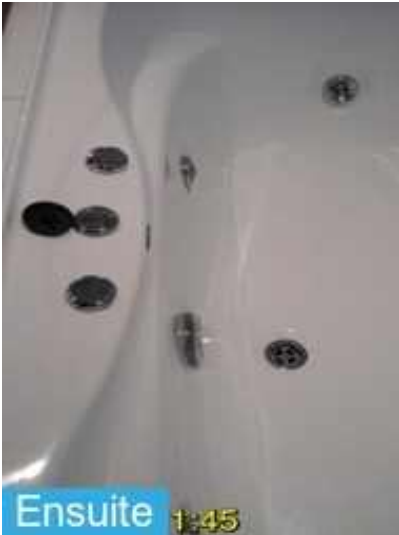
Spa bath recirculation suction/drowning risk. Hazard Identified in Ensuite.

Current Risk	Actions	Potential Solutions	Resultant Risk
Low	Eliminate	Disengage the electric pump to remove the risk of suction or drowning by hair being pulled into the inlet.	Nil
Low	Alert	Safety message to the residents - "As with many properties the presence of lower risk issues are often present. As a result we respectfully ask that you, your family and your guests take suitable care when using the spa bath and in particular be vigilant of young children when in use. Your cooperation will increase the safety for all."	Very Low

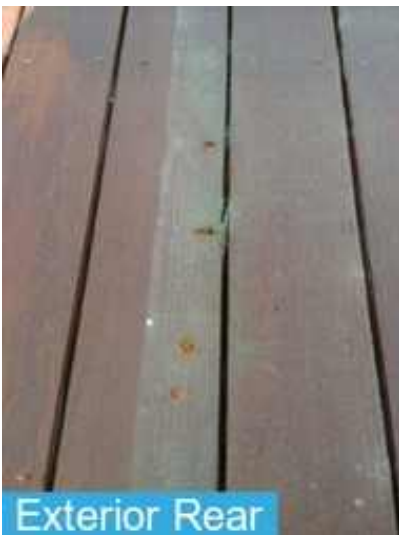
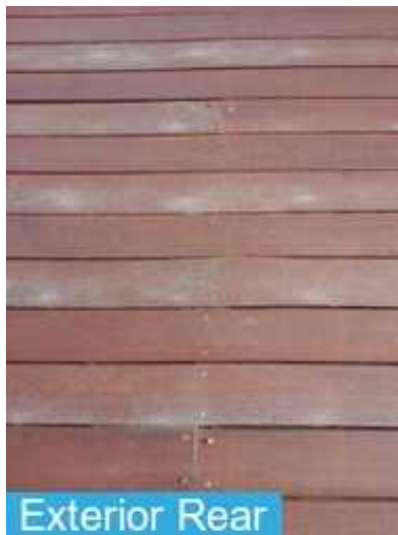
Sharp conditions risk due to the following condition: protruding nails. Hazard Identified in Exterior Rear.

Current Risk	Actions	Potential Solutions	Resultant Risk
Low	Eliminate	Reduce, remove or improve the circumstances associated with the sharp item or condition.	Nil
Low	Alert	Safety message to the residents - "As with most properties the presence of lower risk building issues are often present like sharp edges and corners. As a result we respectfully ask that you, your family and your guests take suitable care when near this issue, and in particular be vigilant of young children, unsteady adults and the elderly. We thank you for your cooperation. "	Very Low

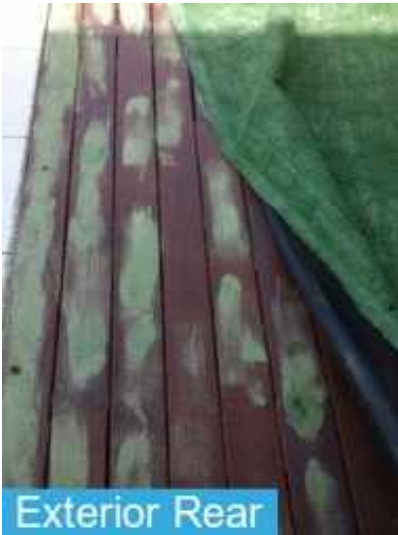
Structure(s) present at risk of deterioration in the near future due to decay.  
Hazard Identified in Exterior Rear.

Current Risk	Actions	Potential Solutions	Resultant Risk
Observations	Alert	Inform the home occupants of the risk and request they report any evidence of unsafe deterioration or damage as it becomes evident to the property owner or manager for immediate rectification.	N/A

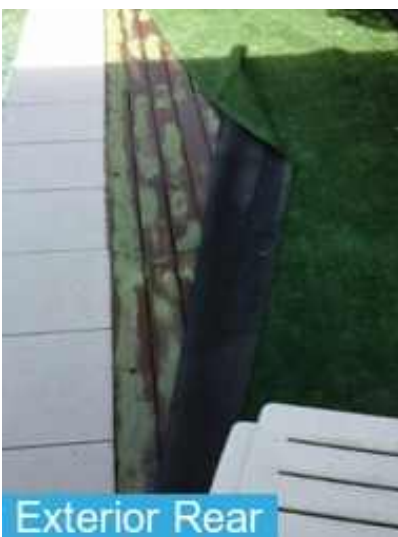
Fixed floor covering trip risk due to: being damaged. Hazard Identified in Exterior Rear.

Current Risk	Actions	Potential Solutions	Resultant Risk
Low	Eliminate	Level and/or repair the walking surface.	Nil
Low	Modify	Place a non-slip and non-trip covering over the uneven walking surface area.	Very Low
Low	Alert	Safety message to the residents - "As with many properties the presence of lower risk trip issues are often present. As a result we respectfully ask that you, your family and your guests take suitable care when walking in and around the premises and near this issue, and in particular be vigilant of young children, unsteady adults and the elderly. Your cooperation will increase the safety for all."	Very Low

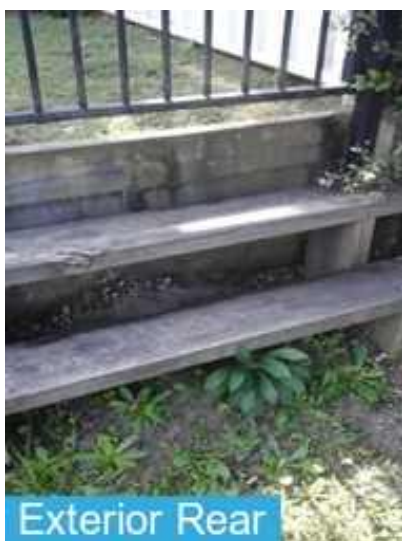
Step/stair dimension risk due to: height greater than 190mm. Hazard Identified in Exterior Rear.

Current Risk	Actions	Potential Solutions	Resultant Risk
Low	Eliminate	Replace with adequately dimensioned step/stairs.	Nil
Low	Alert	Safety message to the residents - "As with many properties the presence of lower risk trip issues are often present. As a result we respectfully ask that you, your family and your guests take suitable care when walking in and around the premises and near this issue, and in particular be vigilant of young children, unsteady adults and the elderly. Your cooperation will increase the safety for all."	Very Low

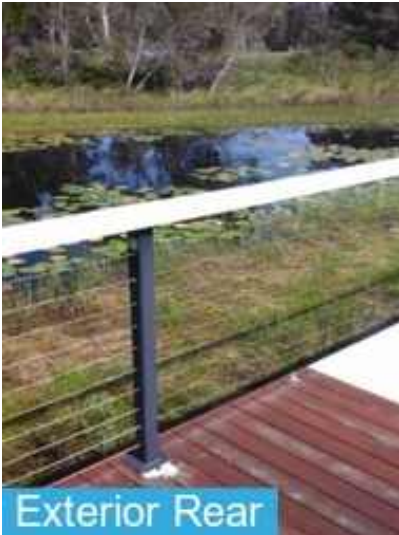
**A greater than 1 metre fall risk due to: penetrable gap within the balustrade greater than 125mm in diameter and fixed climbable opportunity within the balustrade height between 150-750mm. Hazard Identified in Exterior Rear.**

Current Risk	Actions	Potential Solutions	Resultant Risk
Low	Eliminate	In some instances this issue may comply with current building codes although to protect all we recommend the installation of a non-climbable and non-penetrable balustrade to at least 1 metre in height OR cover the internal vertical surface of the existing structure (if appropriate and practicable) with non-climbable and non-penetrable panels (Perspex or other) to at least 1 metre in height.	Nil
Low	Alert	Safety message to the residents - "As with many properties the presence of lower risk fall issues are often present. As a result we respectfully ask that you, your family and your guests take suitable care when near this issue, and in particular be vigilant of young children, unsteady adults and the elderly. Your cooperation will increase the safety for all."	Very Low

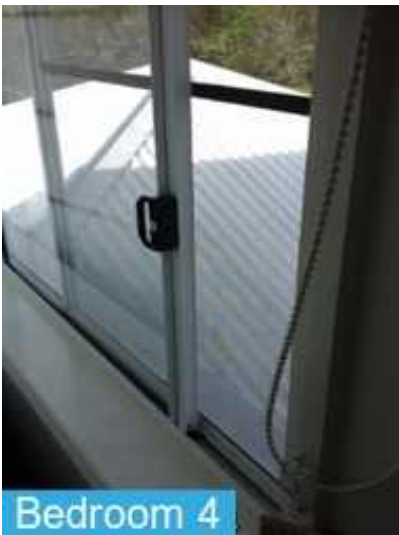
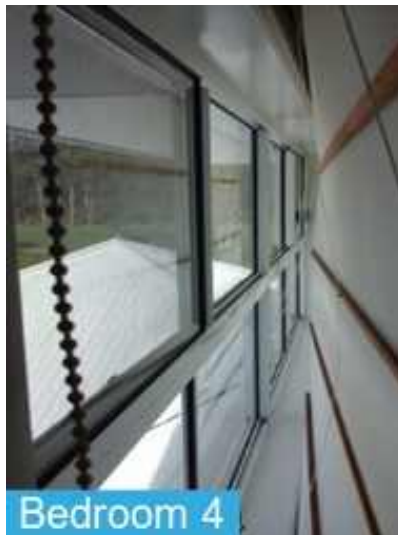
Bedroom window fall risk due to the following conditions: window opening greater than 125mm, window opening less than 1.7 metres from the internal standing surface and a greater than 2 metre external fall. Hazard Identified in Bedroom 4.

Current Risk	Actions	Potential Solutions	Resultant Risk
Moderate	Eliminate	Install a suitable window restrictor or grill leaving no more than 125mm opening.	Nil
Moderate	Alert	Safety message to the residents - "As with many properties the presence of lower risk fall issues are often present. As a result we respectfully ask that you, your family and your guests take suitable care when near this issue, and in particular be vigilant of young children, unsteady adults and the elderly. Your cooperation will increase the safety for all."	Low

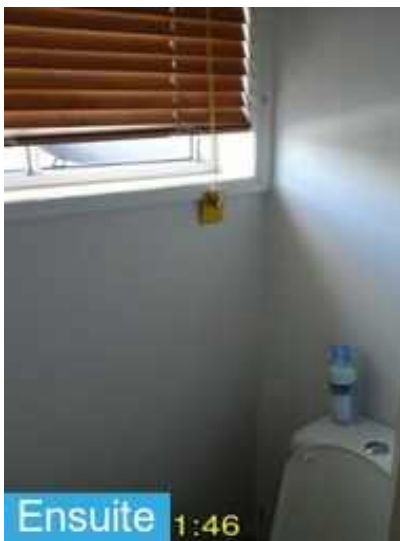
Non-bedroom window fall risk due to the following conditions: window opening greater than 125mm, fixed climbable opportunity as part of or adjacent to the window and a greater than 2 metre external fall. Hazard Identified in Ensuite.

Current Risk	Actions	Potential Solutions	Resultant Risk
Moderate	Eliminate	Install a suitable window restrictor or grill leaving no more than 125mm opening.	Nil
Moderate	Alert	Safety message to the residents - "As with many properties the presence of lower risk fall issues are often present. As a result we respectfully ask that you, your family and your guests take suitable care when near this issue, and in particular be vigilant of young children, unsteady adults and the elderly. Your cooperation will increase the safety for all."	Low

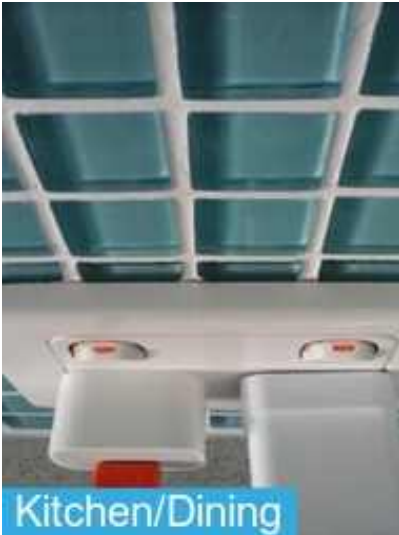
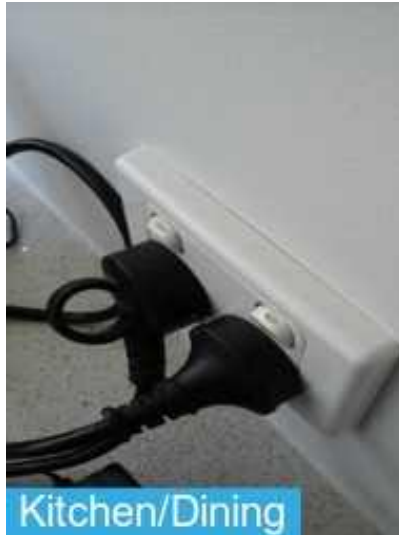
Damaged power point due to the following condition: cracked. Hazard Identified in Kitchen/Dining.

Current Risk	Actions	Potential Solutions	Resultant Risk
Low	Eliminate	Replace or repair the damaged item as required.	Nil
Low	Alert	Safety message to the residents - "As with many properties the presence of lower risk electrical issues are often present. As a result we respectfully ask that you, your family and your guests take suitable care when near this issue, and in particular be vigilant of young children. Your cooperation will increase the safety for all."	Very Low
Low	Isolate	If practicable, as a short term option, prevent physical access to the issue.	Very Low

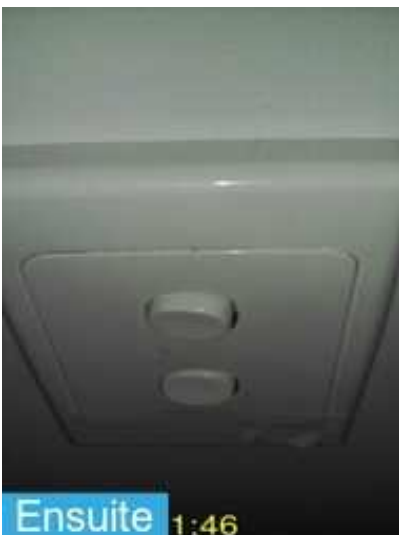
Damaged switch(es) due to the following condition: loose switch. Hazard Identified in Ensuite.

Current Risk	Actions	Potential Solutions	Resultant Risk
Low	Eliminate	Replace or repair the damaged item as required.	Nil
Low	Alert	Safety message to the residents - "As with many properties the presence of lower risk electrical issues are often present. As a result we respectfully ask that you, your family and your guests take suitable care when near this issue, and in particular be vigilant of young children. Your cooperation will increase the safety for all."	Very Low
Low	Isolate	If practicable, as a short term option, prevent physical access to the issue.	Very Low

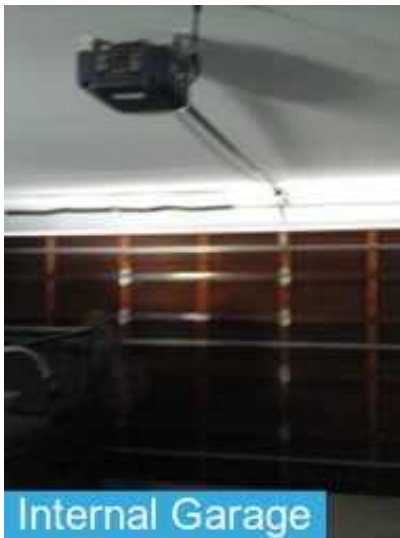
Automatic garage door risk associated with the risk of a child being harmed or injured by the lowering door or after a loss of electricity supply the door not opening for an escape route. Hazard Identified in Internal Garage.

Current Risk	Actions	Potential Solutions	Resultant Risk
Observations	Alert	As our inspection is limited to a visual assessment we recommend you, your property manager or service provider test the door to ensure it stalls or retracts when an obstacle is beneath and confirm there is a manual disengagement option in the event of power loss (fire escape route). If you are currently aware the garage door complies please disregard this issue.	Low

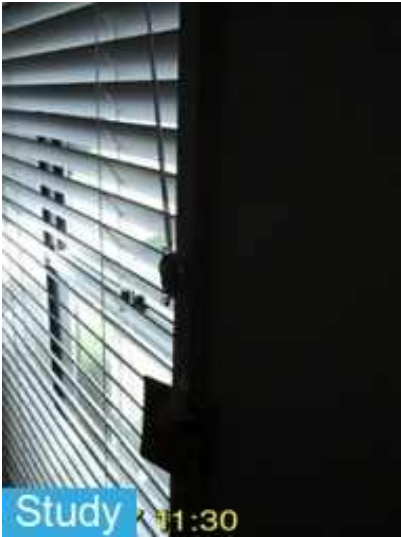
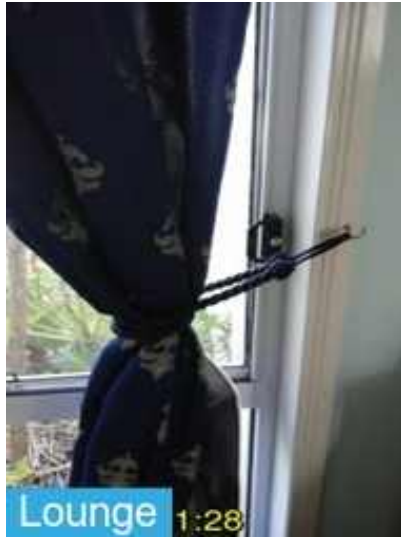
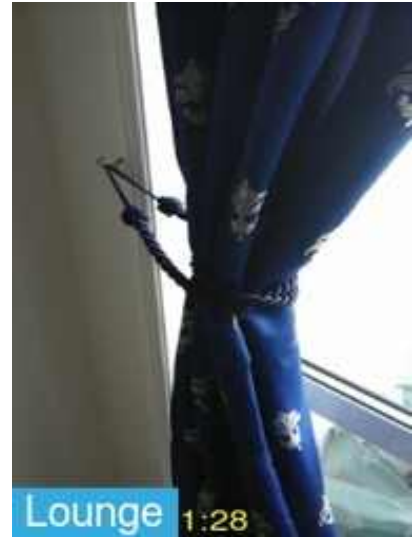
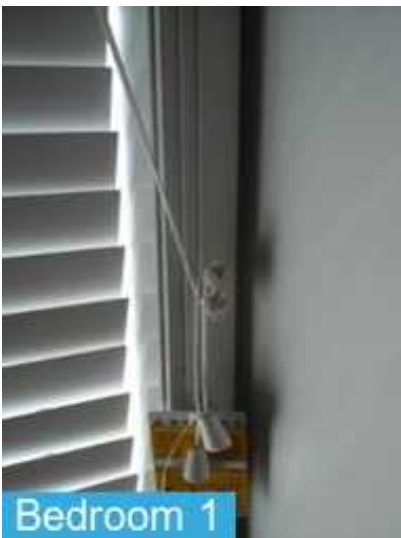
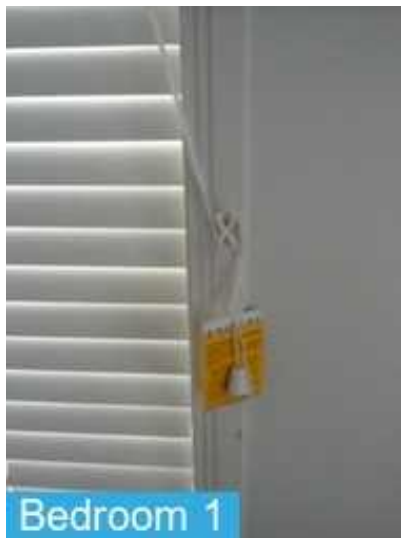
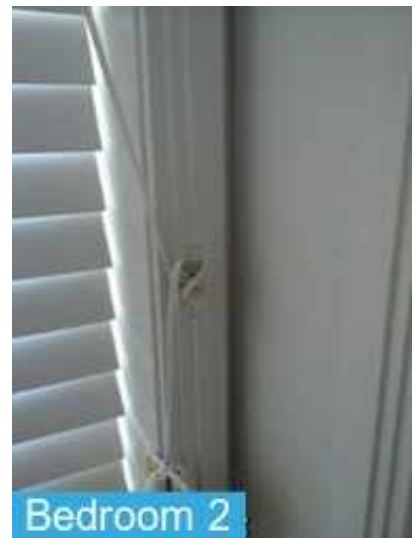
**Curtain/blind cords and/or chains that are unsafe due to the following conditions: lower than 1600mm from the standing surface, not secured adequately and able to form a loop of 220mm in its current state or if intertwined. Hazard Identified in Study, Lounge, Bedroom 1 and Bedroom 2.**

Current Risk	Actions	Potential Solutions	Resultant Risk
Moderate	Eliminate	Replace the blinds and/or curtains with a product that does not contain cords or chains.	Nil
Moderate	Modify	Rectify the issue to comply with legislated requirements of not being able to form a loop of 220mm or more closer than 1600mm from the floor.	Low
Moderate	Alert	Safety message to the residents - "As with many properties the presence of lower risk issues is often present including those associated with curtain and blind cords. As a result we respectfully ask that you, your family and your guests take suitable care when near this risk, and in particular be vigilant of young children. Your cooperation will increase the safety for all."	Low

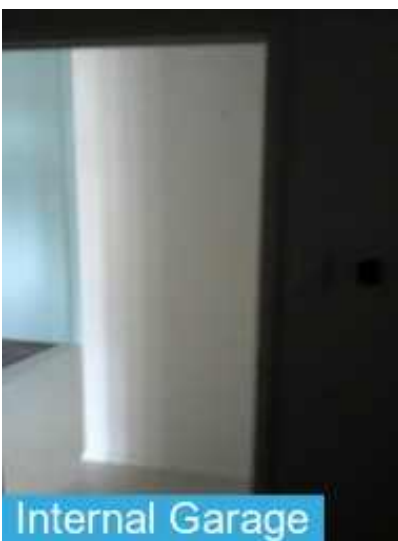
Garage carbon monoxide (CO) risk associated with fumes entering a living space. Hazard Identified in Internal Garage.

Current Risk	Actions	Potential Solutions	Resultant Risk
Low	Modify	Increase ventilation if possible and install carbon monoxide (CO) detectors in and adjacent to the area.	Very Low
Low	Alert	Safety message to the residents - "As with many properties the presence of lower risk issues are often present including the carbon monoxide risk associated with internal access garages. As a result we respectfully ask that you, your family and your guests take suitable care when near this risk including the provision of continuous and adequate ventilation to the area. Your cooperation will increase the safety for all."	Low
