## Pre-Purchase Visual Building & Pest Report

### 1 Sample Street, Sampleton

**Inspection Date/Time:** 2/08/2017.  
**Report Number:** 54321  
**Purchaser:** Mr Sample  
**Inspector:** A Reporter  
**Contact:** 0444 444 444  
**Special Requirements:** Please check for cracks in the living room walls

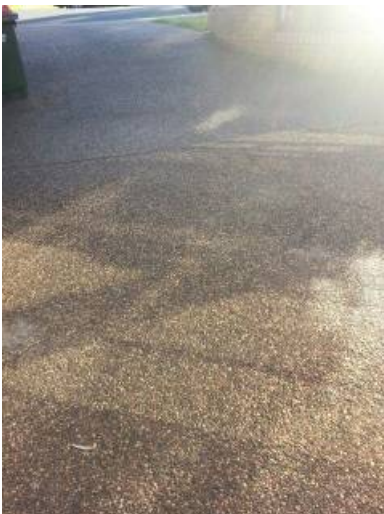
The concrete driveway stands in fair condition.

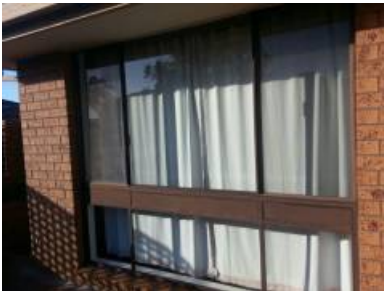
The condition of the exterior of the windows is generally fair.

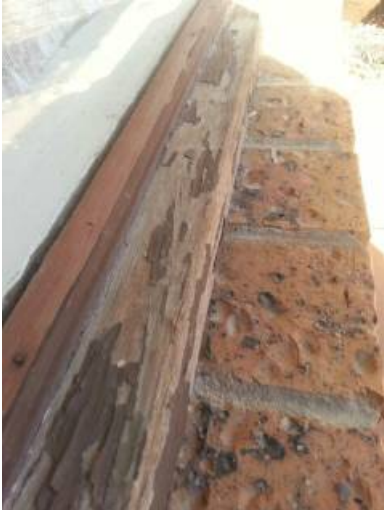
Front elevation.

The condition of the exterior of the doors is generally fair. Paint is peeling off the door frames and maintenance is required. Minor maintenance and or repairs are required prior to next repainting. Rectification will be required.

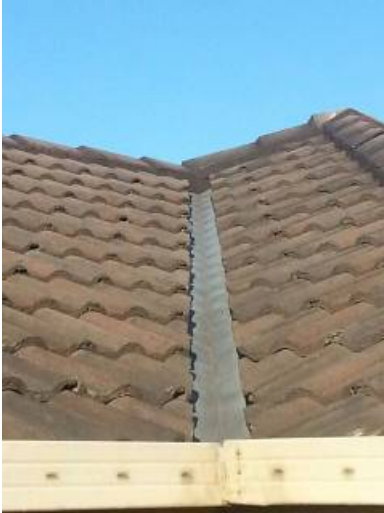
The overall condition of the valley metal is fair.

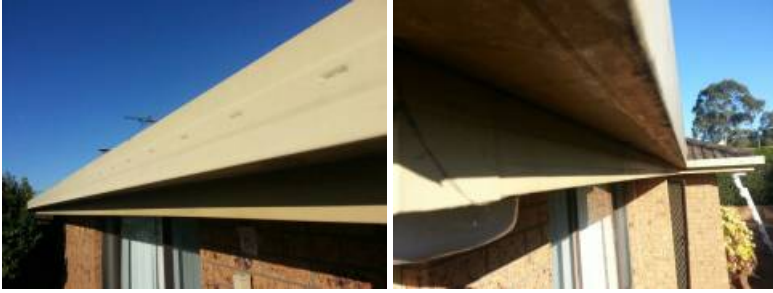
The overall condition of the fascias/bargeboards is fair.

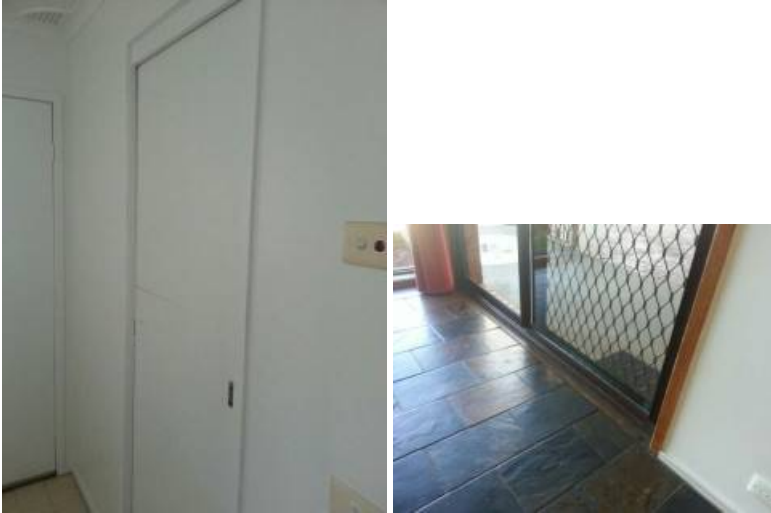
Throughout.

The condition of the doors is generally fair. The door binds and adjustments are required to ensure correct operation. The sliding door/s have poor operation and require adjustment and or repair. The condition of the door hardware is generally fair. Some minor repairs or maintenance will be required.

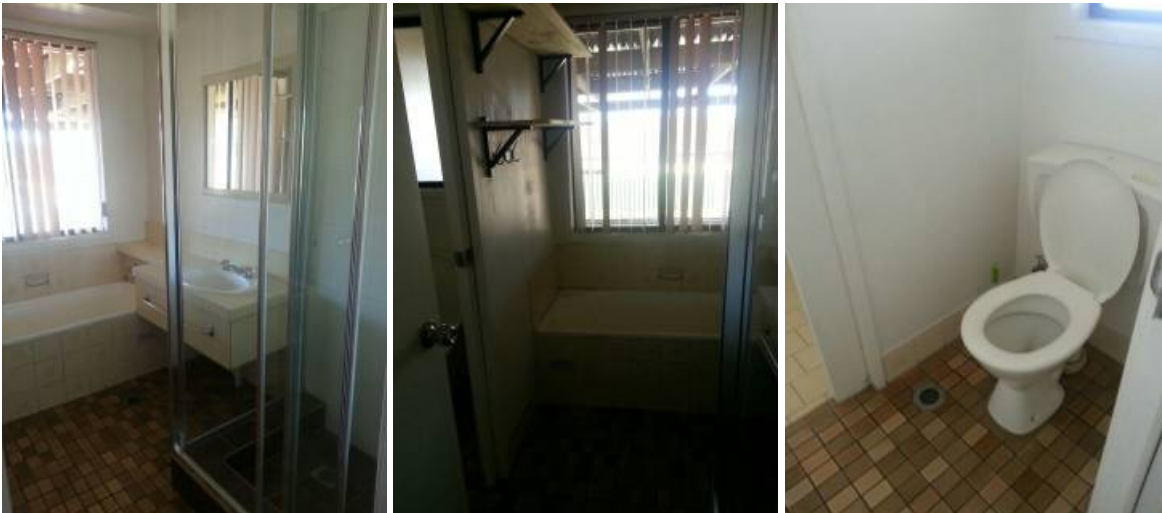
The shower recess was tested and found to be leaking. Lateral dampness was detected in the wall backing onto the shower. This could be the result of a deteriorating /damaged waterproofing membrane, a plumbing leak or leaking bathroom fixture and should be further investigated. Silicone sealant has been applied to the interface of the floor and walls in an apparent attempt to prevent water penetration to surrounding areas. This method of repair can only be considered to be temporary. Further waterproofing may be necessary. The bath appears to be in fair condition. The area will need to be kept well sealed to prevent water penetration to surrounding areas.

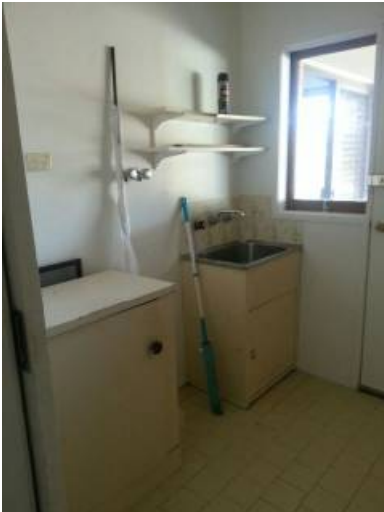
Taps require repair and maintenance to operate correctly. The metal tub cabinet is rusting and will require treatment or replacement.

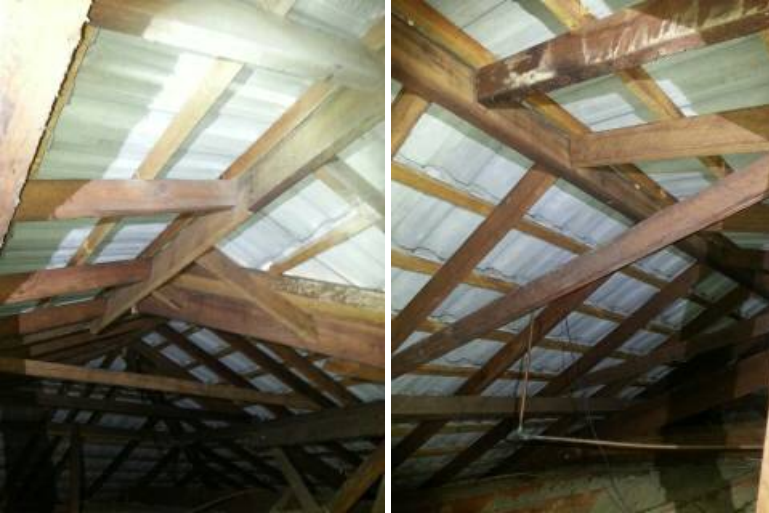
The cut and pitched roof timbers appear to provide adequate support in areas that were accessible. Additional access is required to determine all roof support status.

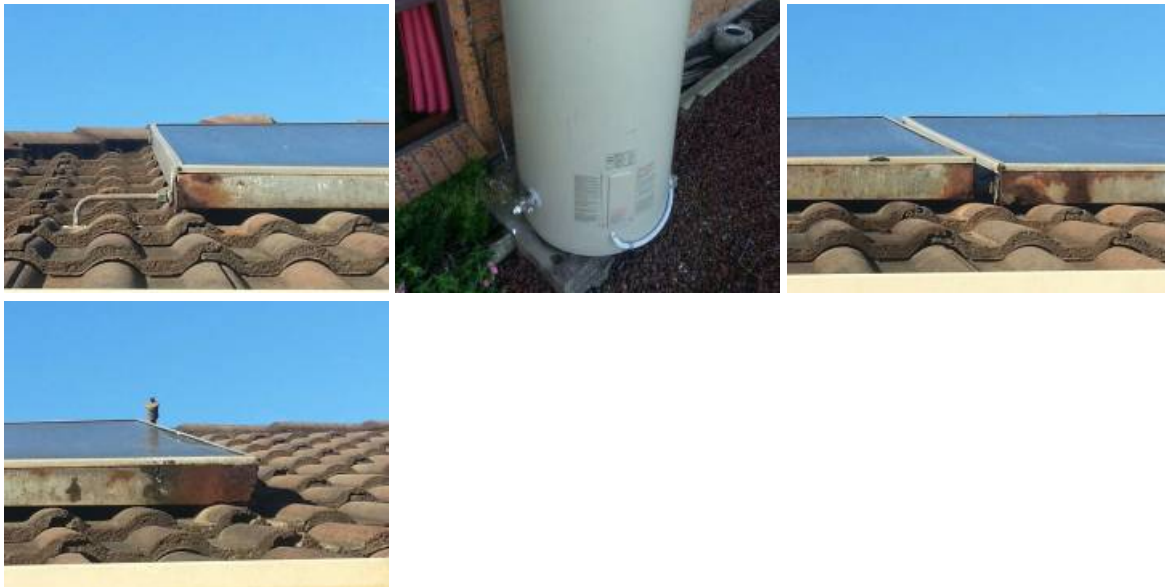
Mains electric hot water system: Solar collector and tank hot water system: Located on the roof: Located externally: No determination has been made as to the suitability or adequacy of the hot water system in relation to capacity or otherwise. Hot water overflow pipe should be diverted away from the external walls. Damp soil around the building may cause swelling and lead to heaving of structure and cracking to walls. Moisture also encourages termites into the area. We strongly recommend the overflow relief valve be connected to a drainage point. The tank may be near the end of its serviceable life and may need to be replaced in the near future.

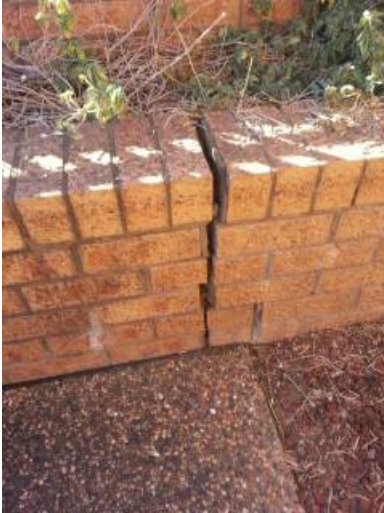
Crack Type: Vertical cracking Located: Pathways Width: 30mm Length: 500mm.

*Due to the unpredictable nature of cracking in building elements it is not possible for the inspector to determine past or future occurrences that have or will impact cracking in this building. Because of these unknowns and the possibility of concealed defects related to cracking in building elements we recommend an engineer be consulted prior to acceptance or purchase this building.*
