Pre-Purchase Visual Building Report

1 Sample Street, Sampleton

Inspection Date/Time: 28/07/2017.
Report Number: 54321
Purchaser: Mr Sample
Inspector: A Reporter
Contact: 0444 444 444
Special Requirements: There are NO Special Requirements / Conditions requested by the Client/Clients Representative regarding this Inspection and Report:

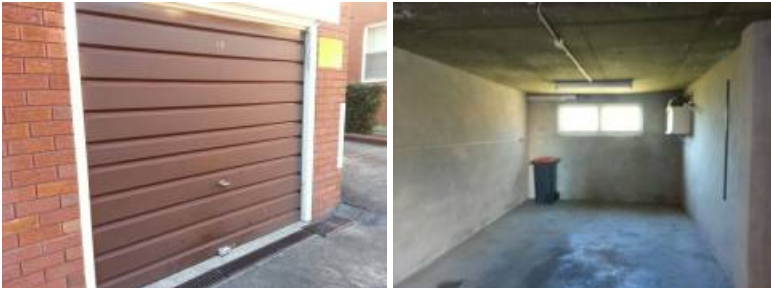
Restrictions:

Defects and or damage requiring rectification may not be apparent to the inspector due to restriction. If restrictions are noted we STRONGLY recommend access be gained to enable a full inspection of the area.

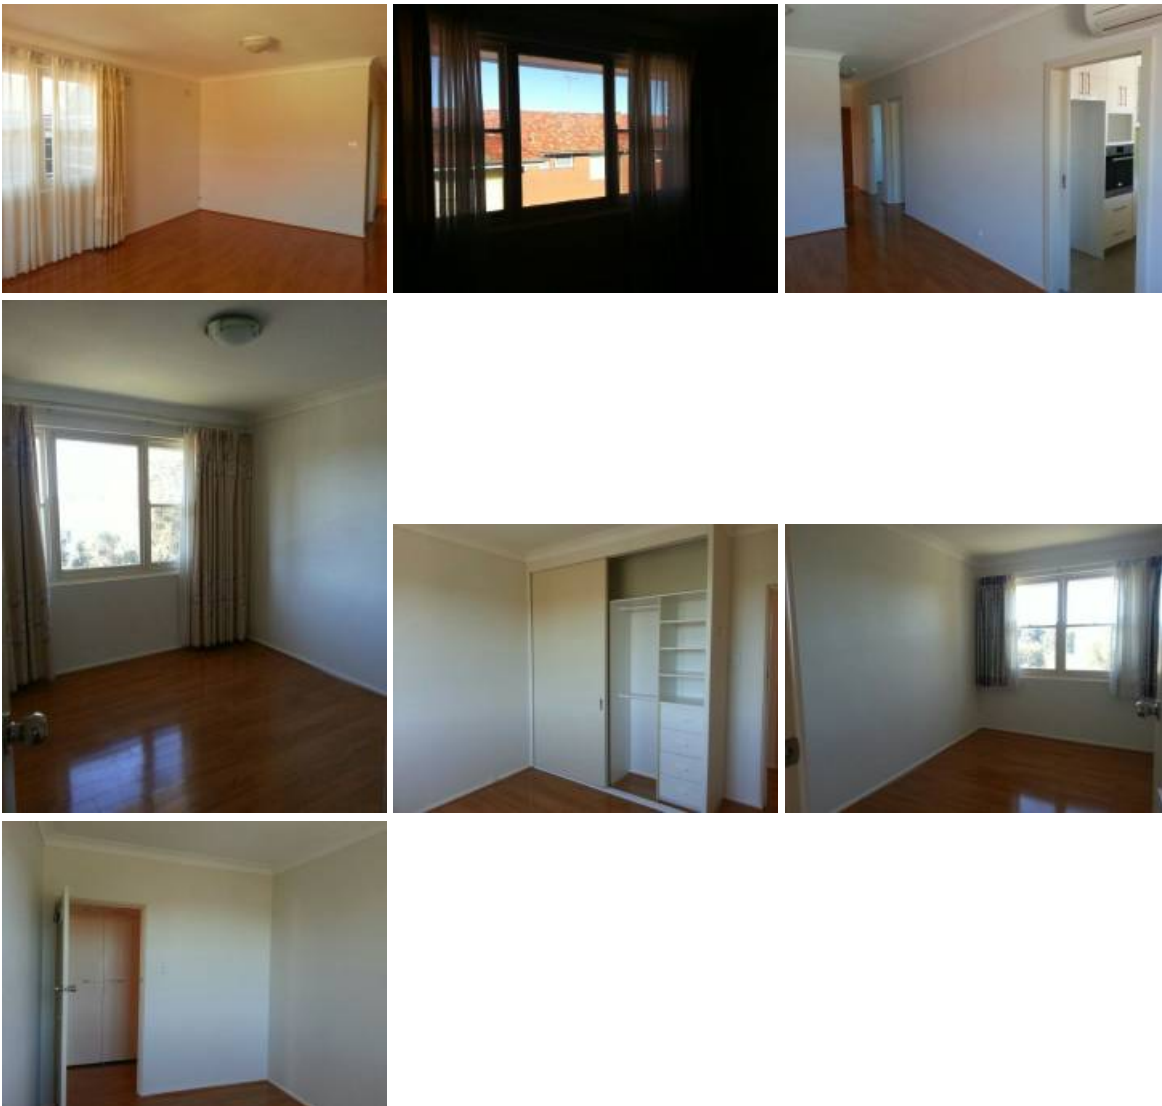
Floorcoverings were present and restricted inspection to the upperside of flooring. Inspection was limited in the following locations and or areas: Various areas. Obstructions are defined as any condition or physical limitation which inhibits or prevents inspection and may include but are not limited to roofing, fixed ceilings, wall linings, floor coverings, fixtures, fittings, furniture, clothes, stored articles/materials, thermal insulation, sarking, pipe/duct work, builders debris, vegetation, pavements or earth.

Defects or damage may be present and not detected in areas where inspection was limited, obstructed or access was not gained.

Defects and or damage requiring rectification may not be apparent to the inspector due to restriction. If restrictions are noted we STRONGLY recommend access be gained to enable a full inspection of the area.

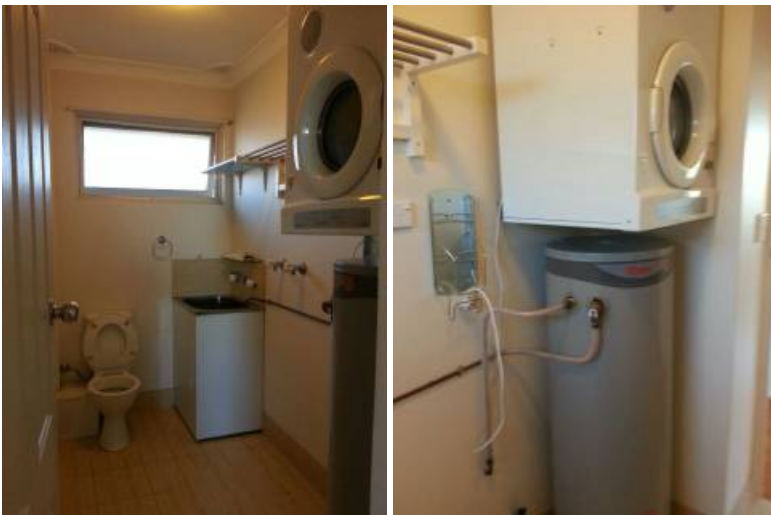
Room Location:

The tub and taps appear serviceable. Drain appears serviceable.

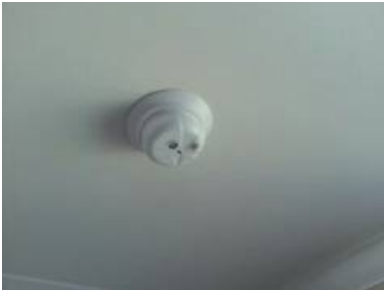
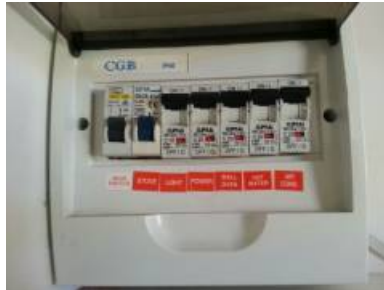
The cold water was operational but the adequacy was not tested and is not commented on. Smoke detectors are fitted, however, the positioning, operation or adequacy was not tested and is not commented on. An earth leakage circuit breaker (safety switch) appears to be installed to the electrical switch board. Positioning, operation or adequacy was not tested.

The evaluation of air-conditioning is not part of a standard pre purchaser building inspection report and is the subject of a special purpose report. We recommend this be carried out by a specialist in air-conditioning installation, maintenance and control.
