## Pre-Purchase Visual Timber Pest Report

### 1 Sample Street, Sampleton

<b>Inspection Date/Time:</b>	10/7/17
<b>Report Number:</b>	54321
<b>Purchaser:</b>	Mr Sample
<b>Inspector:</b>	A Reporter
<b>Contact:</b>	0444 444 444
<b>Client Ref:</b>	N/A
<b>Special Requirements:</b>	Please check for termite activity in the garage

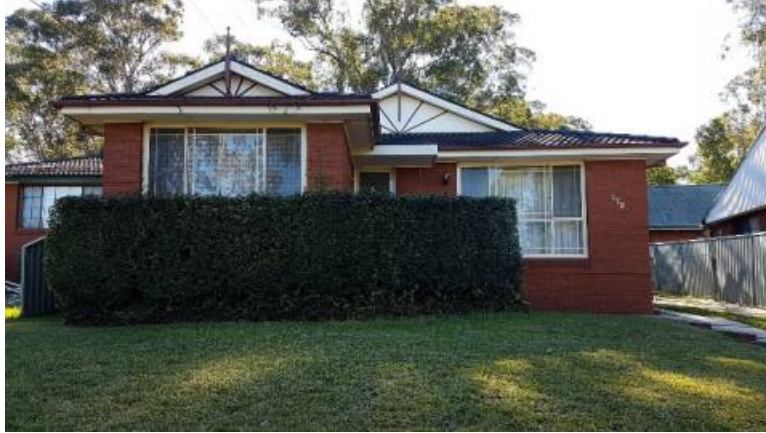
## Property Description

<b>Building Style:</b>	Single storey dwelling.
<b>External Walls:</b>	Brick veneer.
<b>Roof Construction:</b>	The roof is of pitched construction.
<b>Internal Walls:</b>	Plasterboard:
<b>Windows:</b>	Aluminium:
<b>Footings:</b>	The building is constructed on strip footings and piers.
<b>Estimated Age:</b>	Between 40 and 50 years old
