Visual Completion Report

1 Sample Street, Sampleton

Inspection Date/Time:	30/01/2017
Report Number:	54321
Purchaser:	Mr Sample
Inspector:	A Reporter
Contact:	0444 444 444
Special Requirements:	Please meet client on site

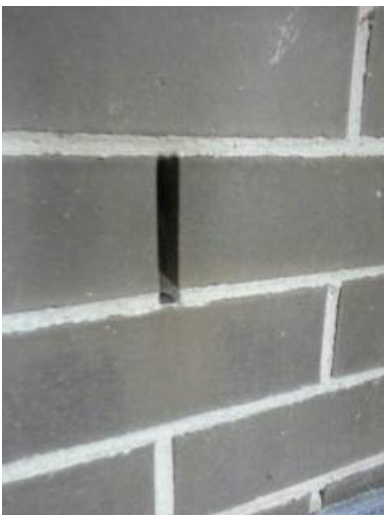
Weep holes are present to the base of walls.

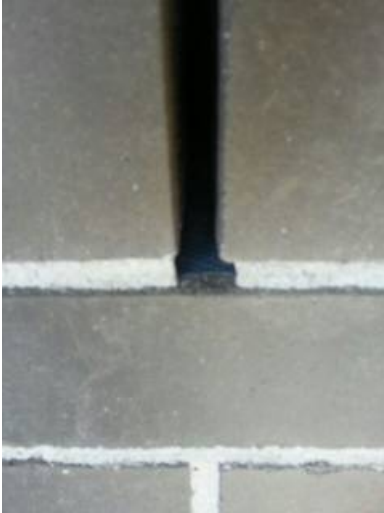
A polythene damp proof coursing material is visible in the external walls and it should continue to be effective unless damaged or bridged.

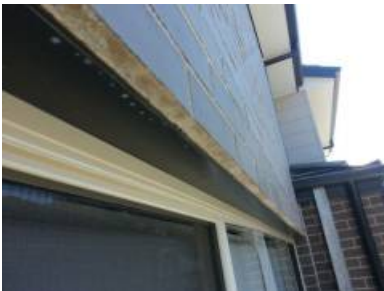
Lintel type/s noted: Galvanised steel: The condition of the lintels is generally fair.

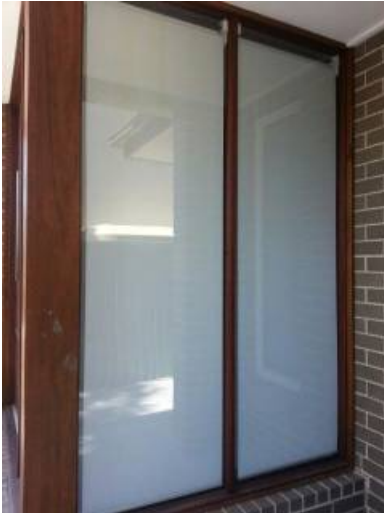
The condition of the exterior of the windows is generally fair.

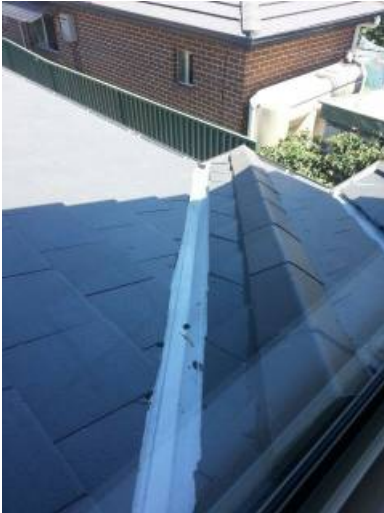
The overall condition of the valley metal is fair.

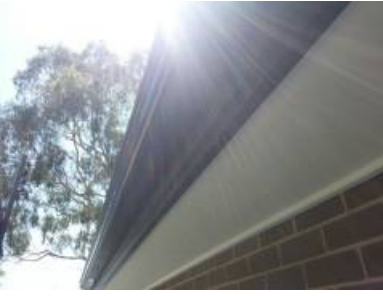
The overall condition of the fascias/bargeboards is fair.

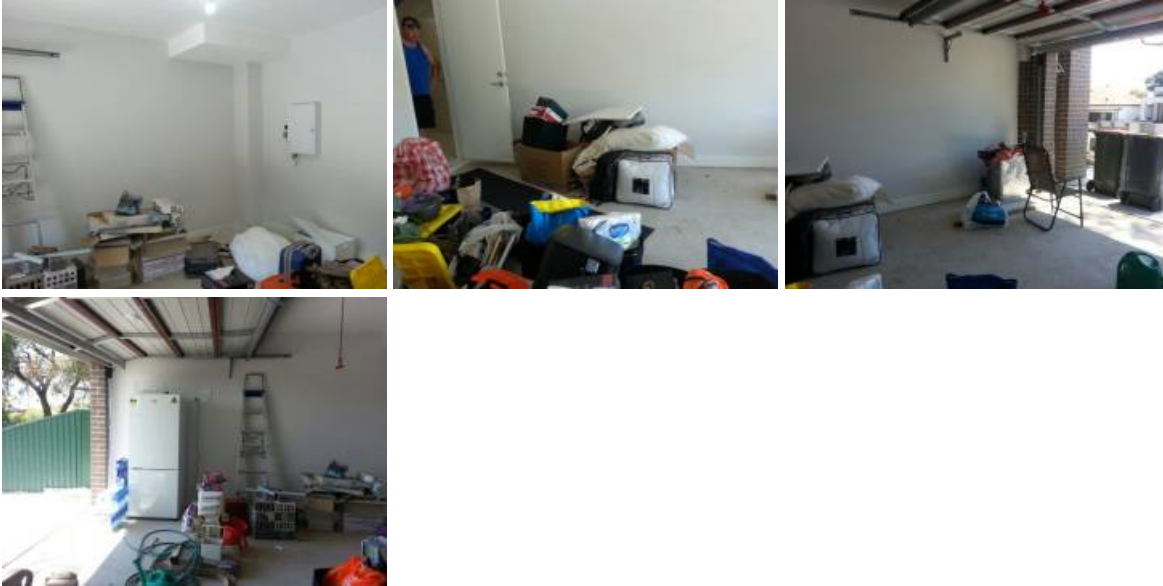
Stored items restricted inspection to the interior. These goods must be removed to enable a more complete report to be submitted. The structure is fully lined preventing inspection to all framing timbers.

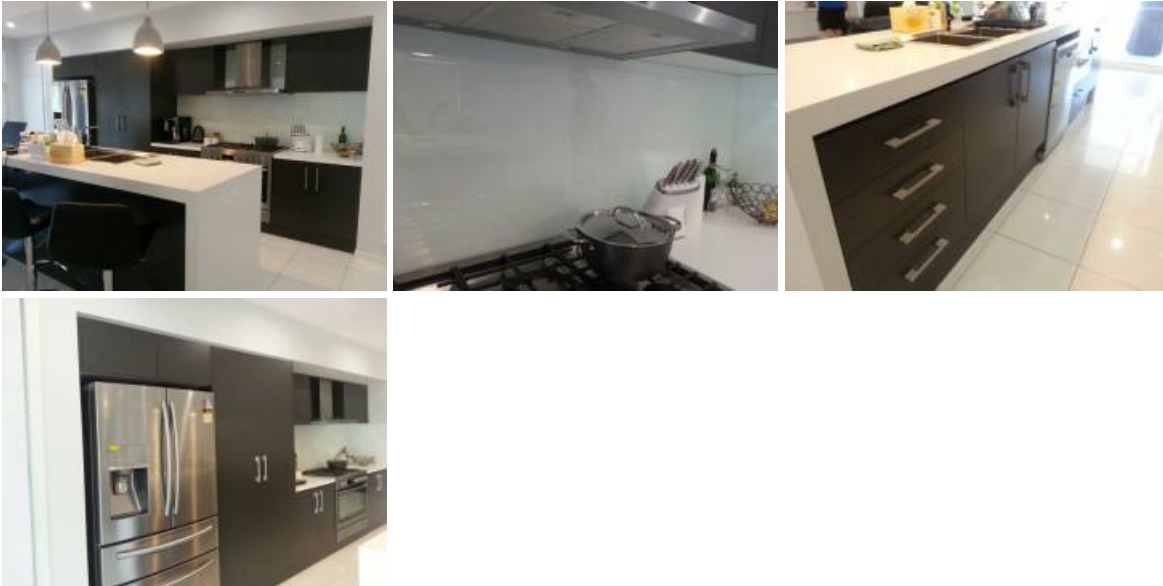
The condition of the fixtures is generally fair. A glass splashback is located over the benchtop area. Glass appears to be in serviceable condition.

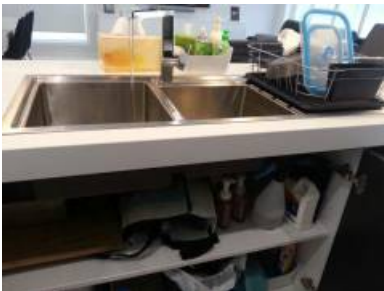
Sink and taps appear in serviceable condition. Drain appears serviceable.

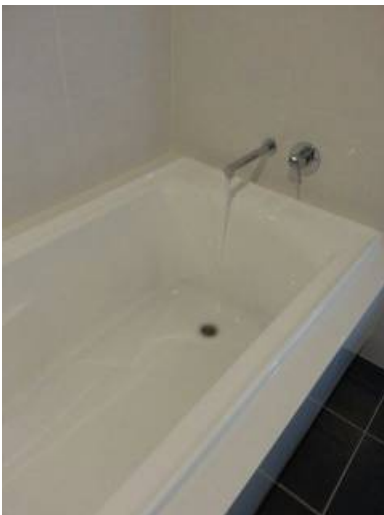
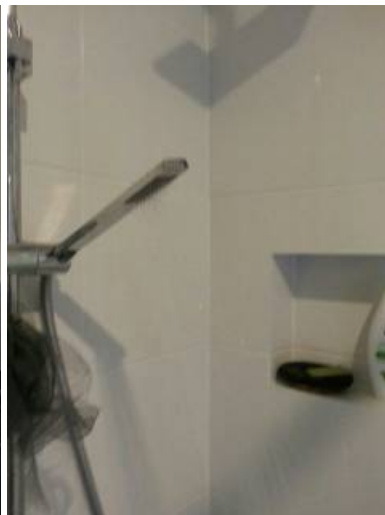
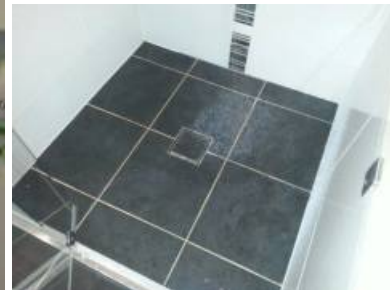
The shower recess was tested and there was no visible water penetration to surrounding areas. **IMPORTANT NOTE:** This test may not reveal water leaks until the shower is put into constant use and surrounding areas monitored over a period of time. The bath appears to be in fair condition. The area will need to be kept well sealed to prevent water penetration to surrounding areas.

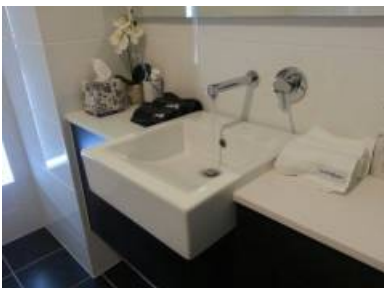
The basin & taps appear serviceable. Drain appears serviceable.

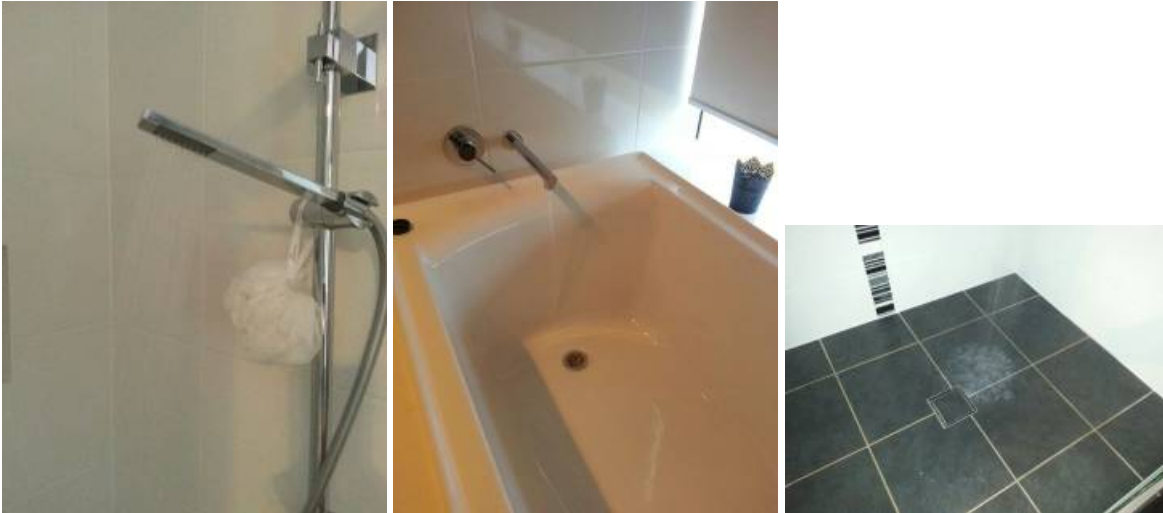
The shower recess was tested and there was no visible water penetration to surrounding areas. **IMPORTANT NOTE:** This test may not reveal water leaks until the shower is put into constant use and surrounding areas monitored over a period of time. The bath appears to be in fair condition. The area will need to be kept well sealed to prevent water penetration to surrounding areas.

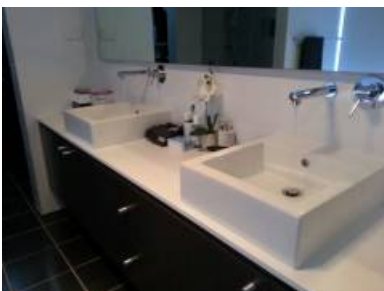
The basin & taps appear serviceable.

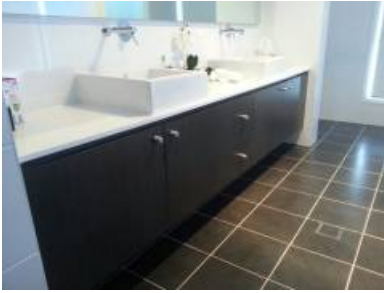
The condition of the vanity unit is generally fair.

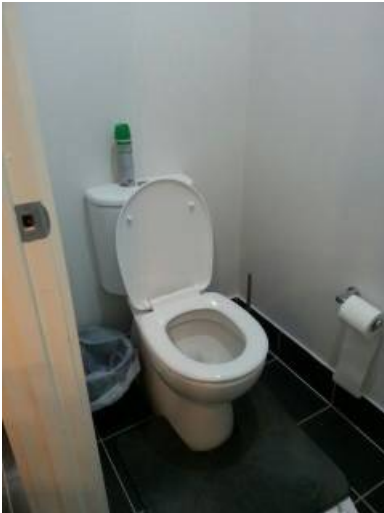
The toilet appears to be in working order.

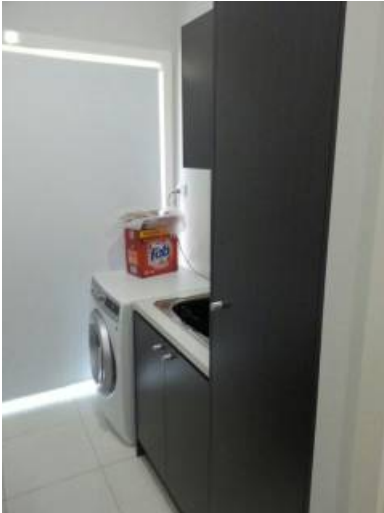
The tub and taps appear serviceable. Drain appears serviceable.

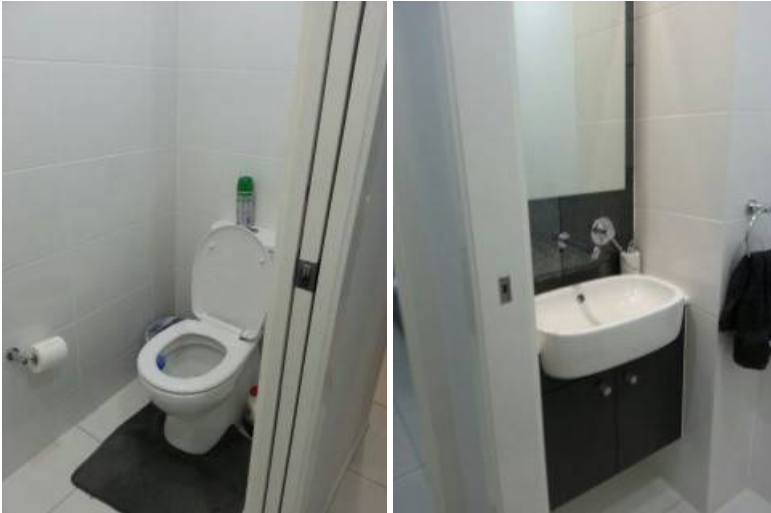
The toilet appears to be in working order.

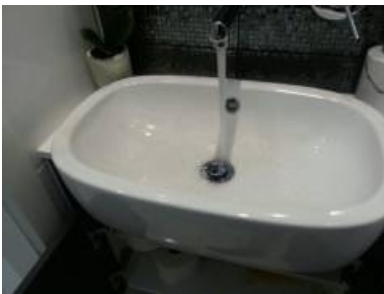
The basin & taps appear serviceable. Drain appears serviceable.

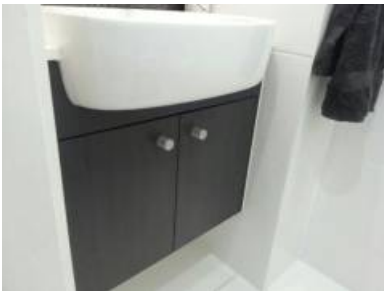
The condition of the vanity unit is generally fair.

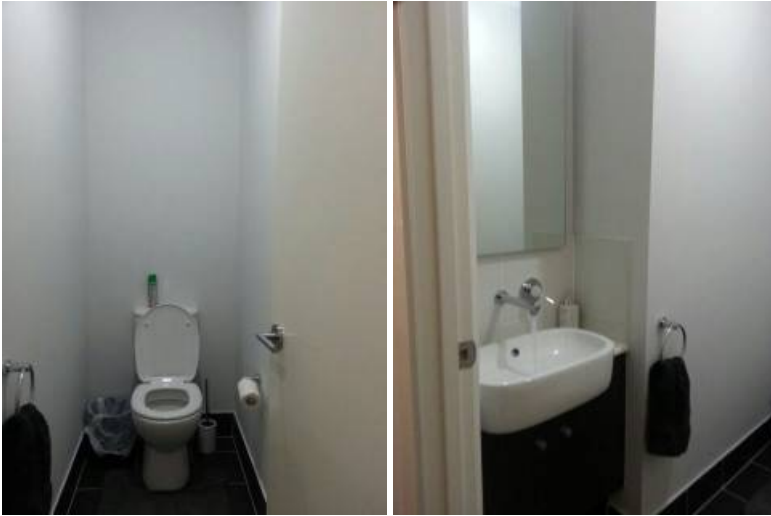
The toilet appears to be in working order.

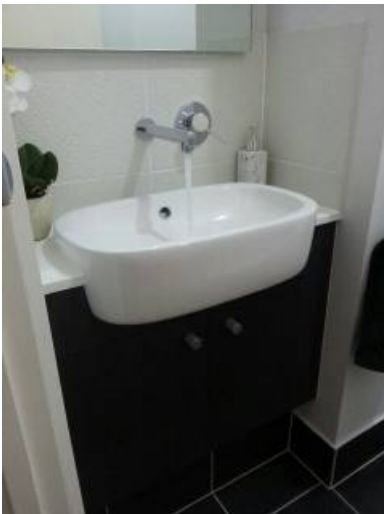
The basin & taps appear serviceable. Drain appears serviceable.

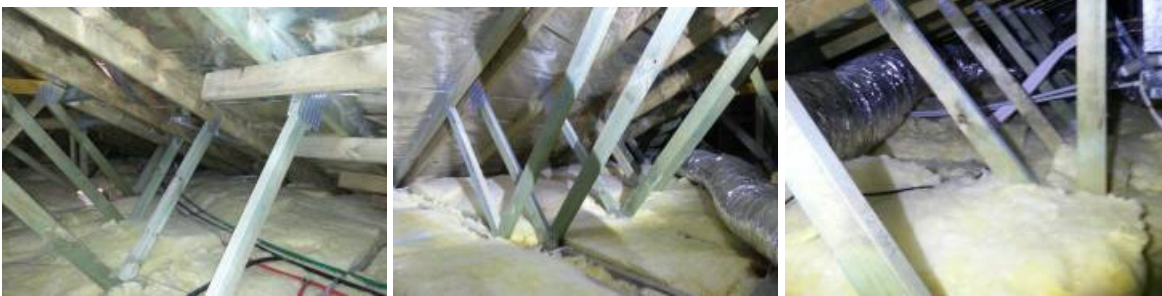
Clearance within sections of the roof was too low to allow body access. This allows only a limited visual inspection from a distance to be carried out. Inspection was restricted above the following locations and or areas: Isolated areas throughout.

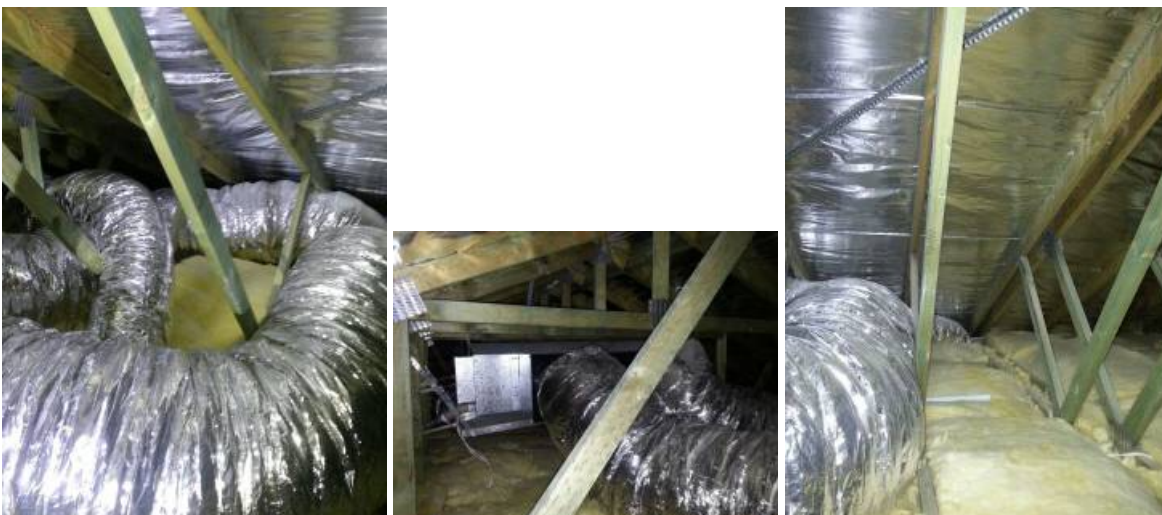
Sarking paper and insulation is present in the roof cavity. This restricted inspection to some roofing timbers. Removal of insulation is not within the scope of a standard visual building inspection report. Ducting associated with air-conditioning or heating restricted inspection. Inspection was restricted above the following locations and or areas: All internal areas.

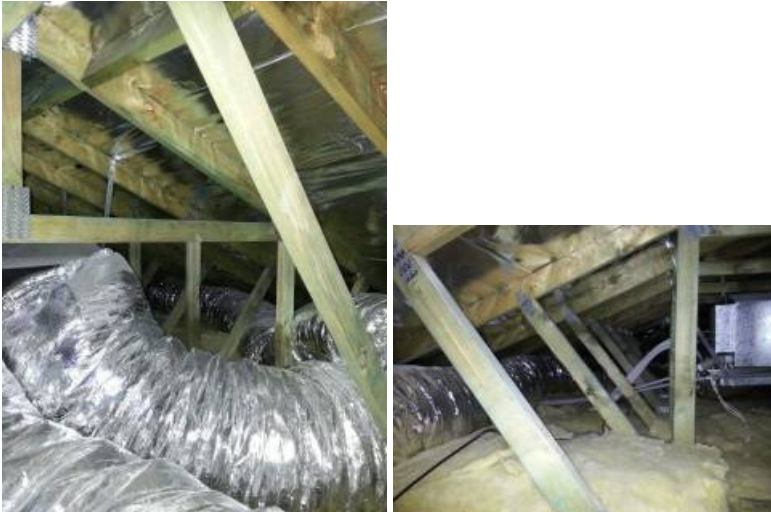
Inspection over the eaves and low areas to the perimeter of the building was restricted due to the low pitch and method of construction allowing only a limited visual inspection from a distance. Items such as top plates and ceiling and roof framing in these areas was not able to be fully inspected. The roof is of trussed style construction and due to the nature of this construction inspection within the roof cavity was limited in some areas. Inspection within the roof cavity was significantly restricted due to the method of construction. This allowed only a very limited visual inspection to be carried out. Roofing timbers above the area(s) listed below were not fully accessed. Inspection was restricted above the following locations and or areas: Various areas.

A comment is not made where access was unable to be gained. Damage and or defects may be present and not detected in areas where inspection was limited, obstructed or access was not gained. If restrictions are noted we STRONGLY recommend access be gained to enable a full inspection inaccessible areas.

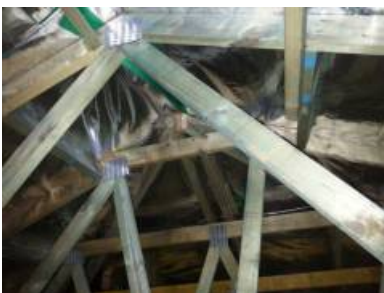
The truss roof system appear to provide adequate support in areas that were accessible. Additional access is required to determine all roof support status.

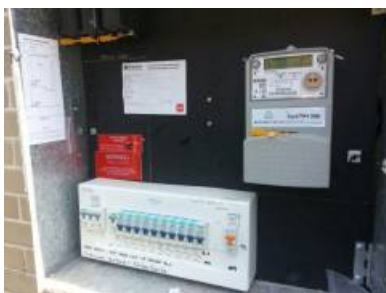
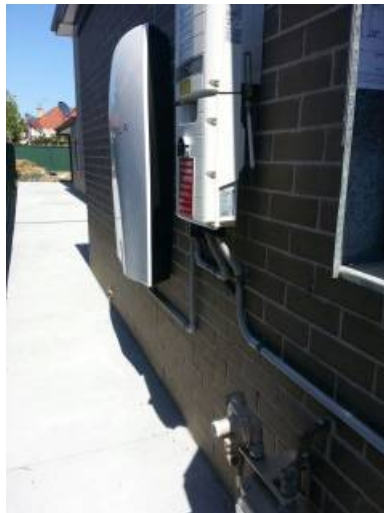
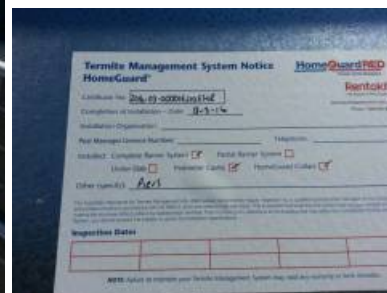
Gas is connected to the premises, however, has not been evaluated and should be inspected by a qualified gas fitter. The cold water was operational but the adequacy was not tested and is not commented on. Smoke detectors are fitted, however, the positioning, operation or adequacy was not tested and is not commented on. An earth leakage circuit breaker (safety switch) appears to be installed to the electrical switch board. Positioning, operation or adequacy was not tested. Solar panels were noted at the property and were unable to be inspected or evaluated. Recommend a electrician qualified in solar power generation evaluate this utility. Solar panels were noted at the property and these were not able inspected or evaluated. Recommend a plumber qualified in solar panel installation and service evaluate further. The evaluation of air-conditioning is not part of a standard pre purchaser building inspection report and is the subject of a special purpose report. We recommend this be carried out by a specialist in air-conditioning installation, maintenance and control. An alarm system is present, however, the operation or adequacy was not tested.

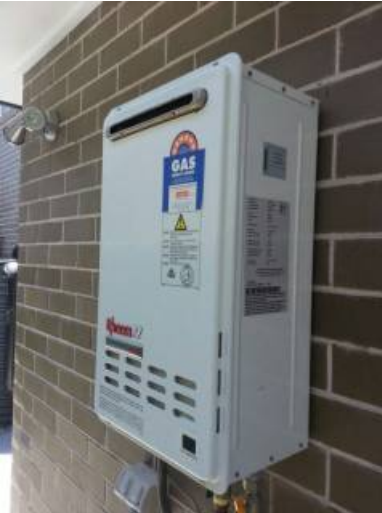
Instantaneous:

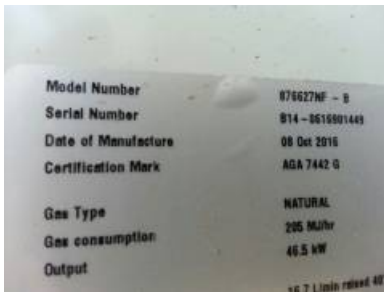
2016.

Important Note: It would be prudent to have all services (visible and non-visible) including electrical wiring, plumbing and drainage etc checked by appropriately qualified contractors.
